Annual Inspection Report

J.B. SIMS GENERATING STATION

CCR Surface Impoundments
Annual Visual Inspection

Unit 3 East and West Ash Pond Surface
Impoundments

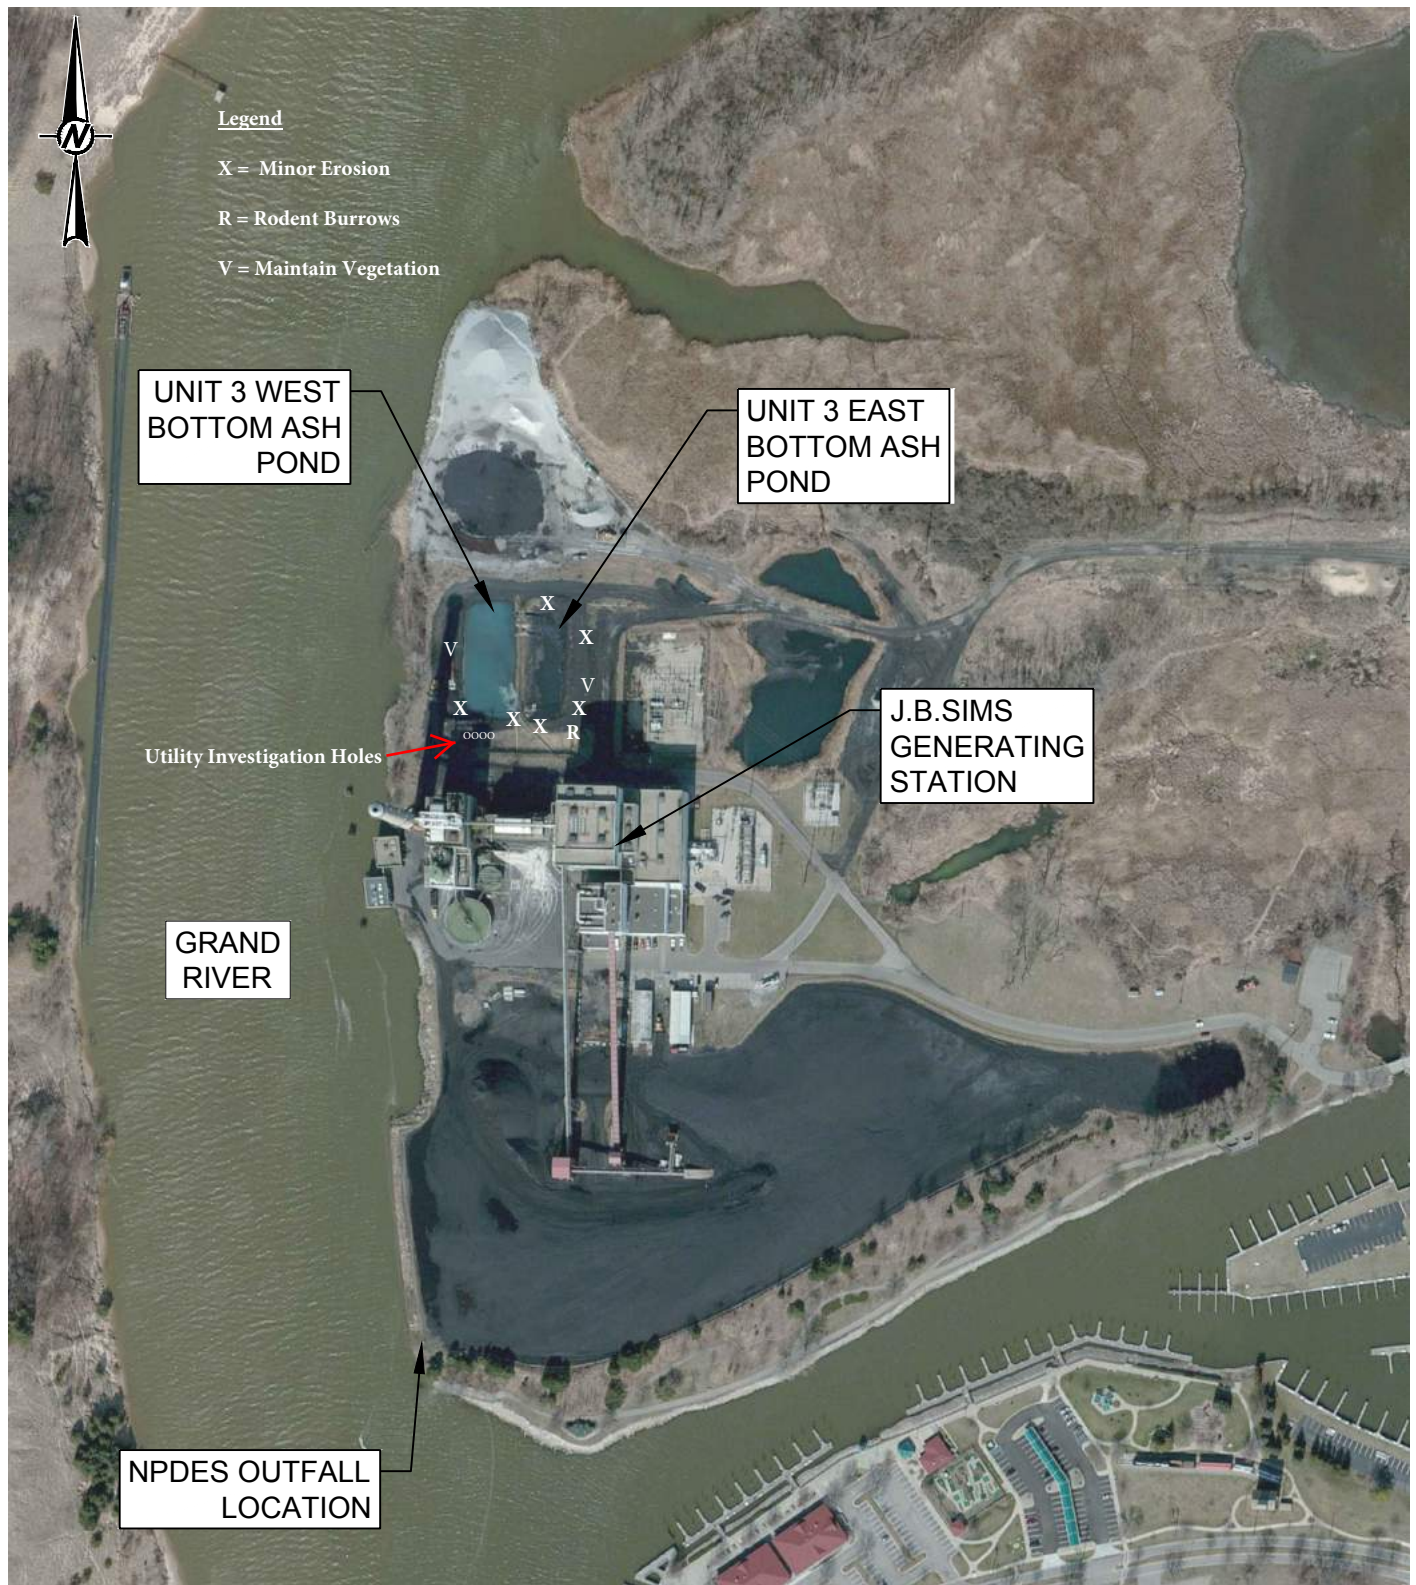
FIGURE
2

| a. Erosion | | X | | | Minor rill erosion along the upstream slope, locations noted on Figure 2. |
| a. Erosion | | X | | | Minor rill erosion along the downstream slope, locations noted on Figure 2. |
| c. Rodent burrows | | X | | | Rodent burrows visible on the south side of the East Pond. GHBLP personnel have installed rodent traps to mitigate further incidences. Location noted on Figure 2. |
| f. Other | | X | | | Underground utility investigation holes encountered along the southern toe of the West Pond, locations noted on Figure 2. |
