Regarding: Grand Haven BLP - Ash Impoundment Evaluation
Grand Haven, Ottawa County, Michigan
Project No. 2016.0329

Soils & Structures is pleased to present the report of the annual inspection the ash (CCR, Coal Combustion Residuals) surface impoundments at the Grand Haven Board of Light & Power Plant.

Dam/Impoundment Visual Inspection Summary

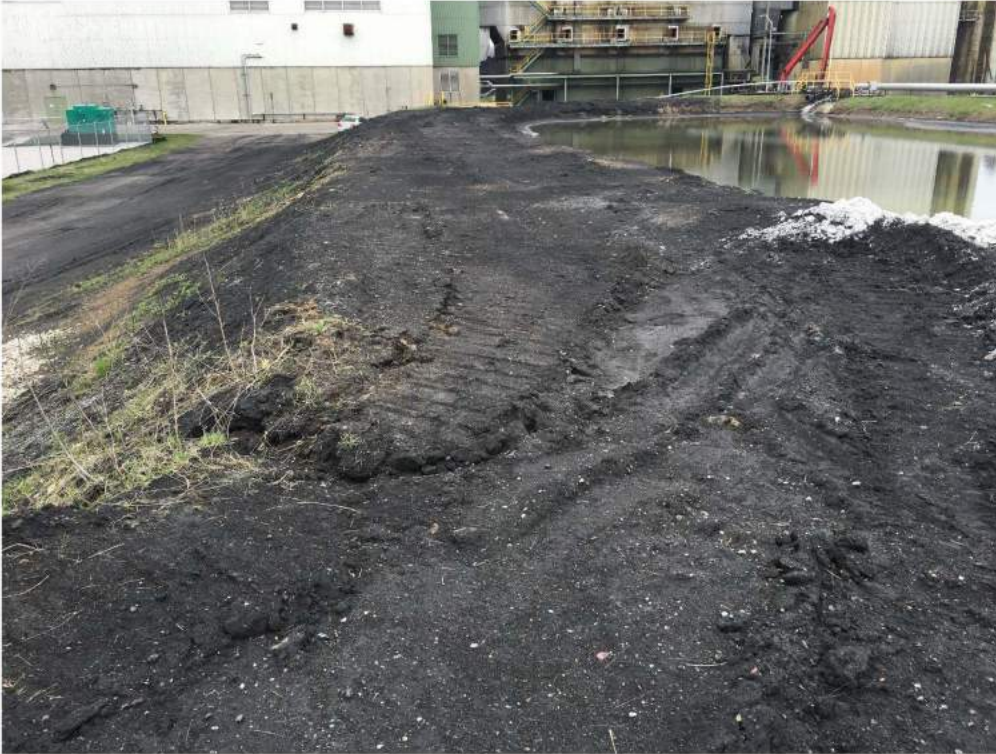
Photograph #1: East berm of the east embankment. Vegetating the exterior slope is recommended. The view is to the south. (Grand Haven Board of Light & Power, Ash Impoundments, Grand Haven, Michigan, June, 2016)

a. Settlement / Slumping	X					None
b. Erosion				X		East side of east pond. Shallow gullies or washouts up to 12" deep. Note (A)
c. Rodent burrows	X					None

d. Vegetation				X		Grass with well-established root structure except on east face of east pond. Note (A)
e. Erosion Protection				X		Grass with well-established root structure except on east face of east pond. Note (A)

Based on this inspection one item is recommended for repair. The exterior side of the berm that forms the east side of the east impoundment is recommended. The recommended detail is 3.0 inches of topsoil covered by a seeded erosion control mat. The recommended erosion control mat is American Green Eronet SC150 Permanent Erosion Control Blanket or equal.

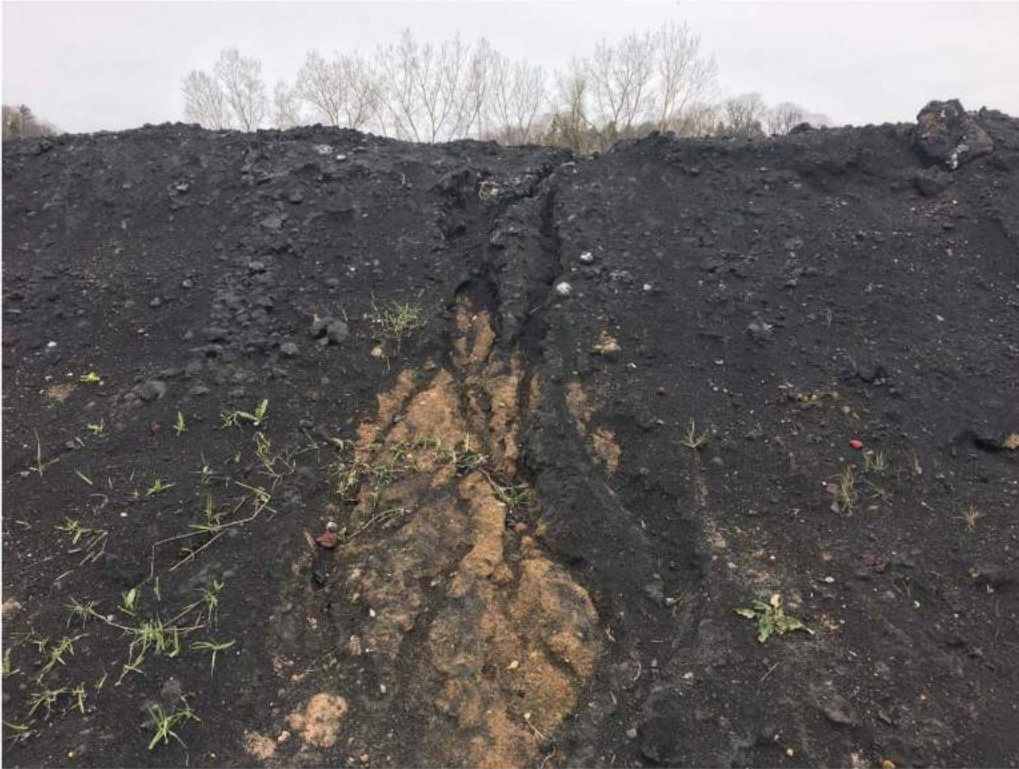
Photograph #2: Typical erosion gully on the exterior face of the east berm of the east embankment. Vegetating the exterior slope is recommended. The view is to the west. (Grand Haven Board of Light & Power, Ash Impoundments, Grand Haven, Michigan, June, 2016)
