LIFE ASSESSMENT REPORT

J.B. Sims Generating Station Unit 3

Grand Haven Board of Light and Power

13 JUNE 2018

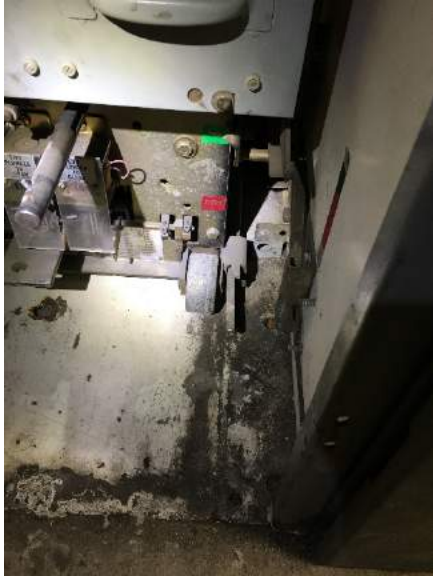
Black & Veatch reviewed available 480V Motor Control Center (MCC) and 4160V switchgear data and the most recent 2016 inspection reports available. All the MCC's and switchgear have reached the end of their useful life and are obsolete; in some cases, switchgear is classified as dangerous. MCC and switchgear replacement parts are not available. Repair and/or replacement is performed by plant electricians and/or fabricated by outside local machine shops. The existing cabinets are worn and would require extensive rewiring to receive new MCC and Switchgear breakers.

Figure 3-1 Photo of 4160V Breaker Cubical Deterioration

Replacement of this equipment requires a long lead time and is not a practical short-term solution to protect plant personnel. Estimated lead time to engineer, purchase and install this electrical equipment is 36 - 48 months. Installation of the equipment will require an extended outage of 4 - 6 weeks where demolition and installation will need close coordination with other outage activities because of the impact to other outage work during loss of major electrical circuits during this time. Black & Veatch does not recommend replacement of the MCC and 4160V switchgear if Unit 3 operation is ceased by June 2020. If it is the intention of the utility to operate beyond 24 months, then Black & Veatch recommends beginning the replacement process immediately. Black & Veatch agrees with the electrical inspection and testing report recommendations dated 2016, in which the inspection team recommended replacement of the equipment. Precautionary maintenance and operation safety procedures should only be used to protect against personnel injury for a short period of time.

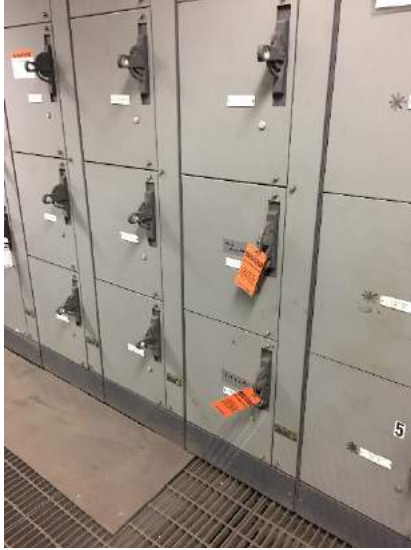
Figure 3-2 Photo of MCC Panel with Do Not Use Tags (Orange)

Black & Veatch recommends GHBLP exercise due diligence in electric equipment safety and procedure compliance. Immediate training by a qualified certified instructor in Arc-Flash safety should be given to all operations and maintenance personnel in accordance with NFPA 70E. The purpose of NFPA 70E®, Standard for Electrical Safety in the Workplace®, is to provide a working area for employees that is safe from unacceptable risk associated with the use of electricity in the workplace. NFPA 70E establishes safety processes that use policies, procedures, and program controls to reduce the risk associated with the use of electricity to an acceptable level. It is imperative that everyone in the plant knows and understands the cause and effect of an arc flash. Specific arc flash training should be conducted to include preventative measures and proper personal protective equipment necessary for each hazard level. GHBLP should have their Operation and Maintenance procedures pertaining to MCC's and switchgear reviewed and modified by a qualified and certified consultant who is familiar with the equipment and its current condition and NFPA 70E standards.

Black & Veatch recommends no maintenance be performed on 480 V MCC and 4160V switchgear buckets and breakers while on line. Switching On/Off the equipment should be done by remote control switching. If the equipment is not equipped with remote switching capabilities, then all safety precautions must be implemented for personnel protection in accordance with NFPA 70E.

Black & Veatch recommends that non-essential personnel access be restricted near or entering MCC & Switchgear rooms or enclosures during online operation. Areas which are designated as general access locations, such as the Unit 3 scrubber control room, electrical equipment rooms and walkways between 408V and 4160V equipment, should be restricted, allowing only essential O&M personnel during electrical maintenance functions. If electrical work is being performed in the area, O&M personnel should wear properly rated flash protection PPE in accordance to NFPA 70E for the distance working from the electrical equipment.

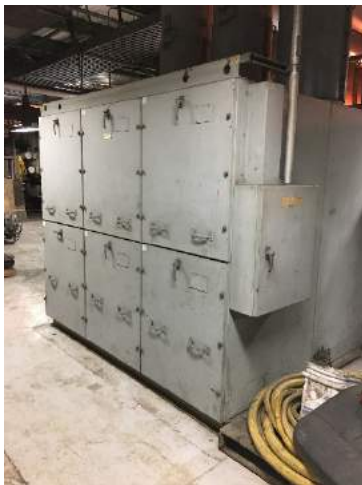
Unit 3's Generator Potential Transformer (PT) cubicle is in poor condition. Original cabinet safety switches are obsolete and unavailable. There are no keys to the safety locks on the cubicles; therefore, there is no restricted access. A cabinet could be accidentally opened while on line, causing an explosion due to a ground fault injuring personnel. GHBLP should immediately find an acceptable locking system for the cabinets.

Figure 3-3 Photo of Generator PT Cabinet

If it is decided to run the plant over 24 months, work should begin immediately for replacement of the potential transformers and locking cabinets to ensure proper time for engineering, procurement, and coordination with the next major outage scheduled for 2020. Appendix A includes replacement costs.

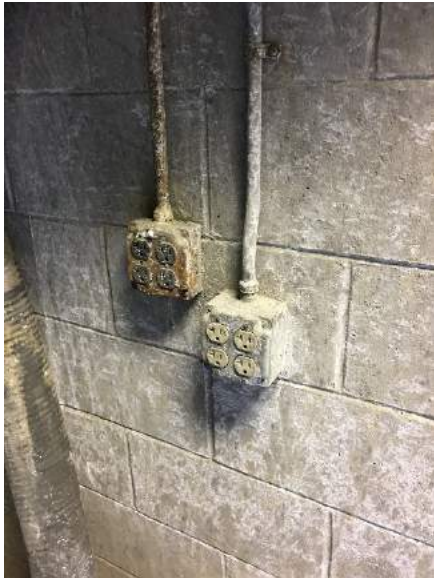
Low voltage wiring and electrical panels in the scrubber building have deteriorated from years of exposure to the corrosive conditions shown in Figure 3-4. As the equipment continues to deteriorate, additional maintenance is required to keep electric equipment, switches and receptacles operable. Performing maintenance on these systems is becoming increasingly dangerous. In some cases, light switches and wall outlets are restricted from use because they are not safe to use.

Figure 3-4 Photo of Corroded Receptacles

Replacement of the low voltage system in the scrubber building should be considered for personnel safety. Black & Veatch recommends performing an assessment of the low voltage system within 6 months to identify immediate safety issues and mitigation. The assessment can be used for determining the work scope for replacement if Unit 3 runs longer than 24 months. An assessment cost estimate for the low voltage system is included in Appendix A.

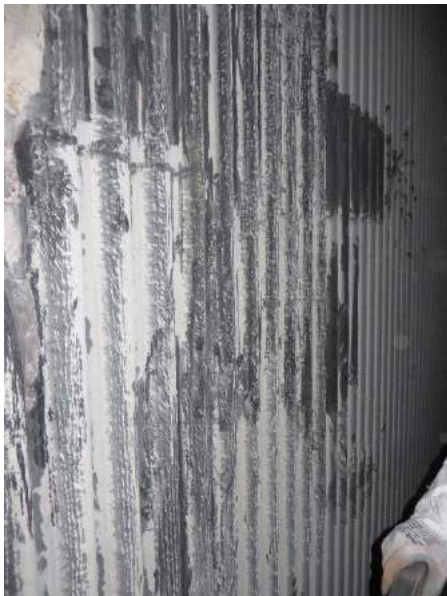
The most recent boiler tube testing and analysis was conducted in 2008. Boiler tube thickness testing should be routinely scheduled during annual outages to keep track of erosion patterns and tube thinning. Past analysis reports concluded the tubes’ material was approaching its useful life. With continued operation these tubes will fail, causing forced outages, collateral damage to surrounding tubes, and risk of injury to personnel.

Figure 3-5 Photo of Boiler Tubes with Weld Overlay to Extend Life

Failure of a boiler tube can potentially impact personnel working around the boiler. Tube failures typically fail in the direction of the fire side (inside) of the boiler, directing the energy into other tubes and space within the boiler with little effect to the outside area. There is the possibility of a cold side failure, however; inspection and testing is required to map potential failure areas and subsequently set up restricted boiler zones for personnel protection. Black & Veatch recommends implementing a sampling and testing program for boiler tubes within the next 6 months.

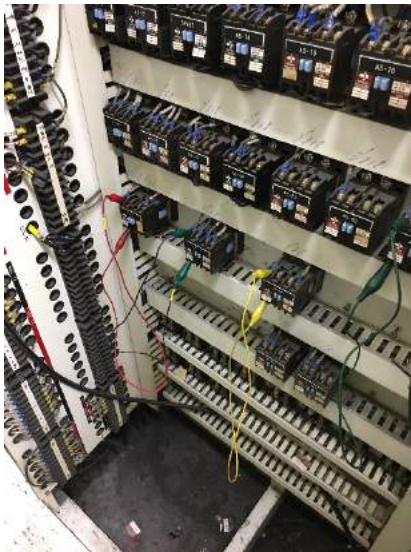
The OEM for the boiler, turbine and scrubber controls has recommended replacement of these systems because they are obsolete; parts and service are not supported. Control system problems are a constant issue for operations and maintenance. In some instances, some control circuits must be jumped for continued operation.

Figure 3-6 Photo of Relays with Jumpers

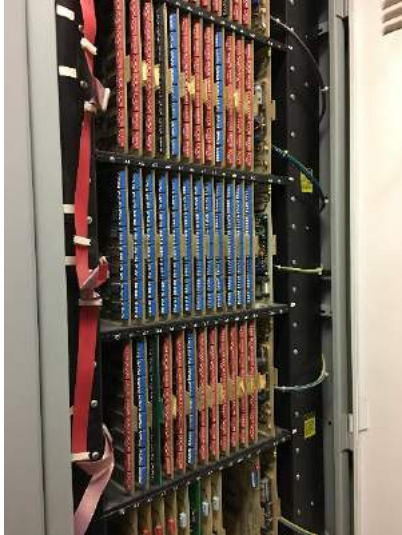
Black & Veatch did not find where critical system protection has been jumped. GHBLP Maintenance has a supply of extra control modules and replacement parts, but will soon run out and not be able to buy replacements. Some parts have been purchased on eBay due to no OEM parts being available.

Figure 3-7 Photo of Obsolete Control Module Cards

The control systems are becoming an increasing factor in Unit reliability. Replacement of these control systems will be required for continued operation in the future. A cost estimate has been included for the replacement of the Boiler, Turbine and Scrubber control systems. The replacement of the controls will take an extended downtime period and should be conducted in coordination with the next major outage. GHBLP staff has been in discussions with ABB to provide emergency support in case of boiler or scrubber control failures. Although these programs are no longer supported, ABB will provide whatever assistance they can until the controls have been replaced. Until that time, the plant's reliability is in question with the current controls. Replacement costs are included in Appendix A.

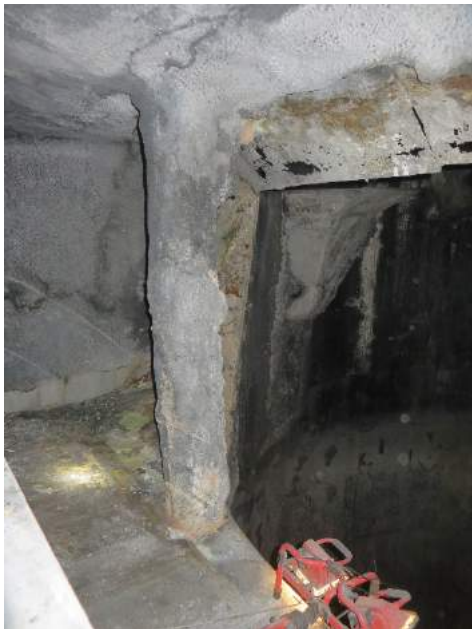
Vendor recommendations and visual inspection confirm expansion joints, ducts and dampers are seriously degraded and need replacing and repair.

Figure 3-8 Photo of Degraded Coating and Flue Gas Deflector

Leaking expansion joints affect system process stability, work area safety and duct structural movement. Dampers are required for proper air flow distribution between scrubber vessels and for safe isolation of a scrubber vessel for maintenance. Ducts which are the conduit for the flue gas to be conveyed between the boiler and chimney must be free from leaks and have sufficient structural strength to support themselves. Flue gas duct leaks directly impact Net Unit Heat Rate.

Costs for replacement of the expansion joints and dampers within the scrubber duct system are included in Appendix A.

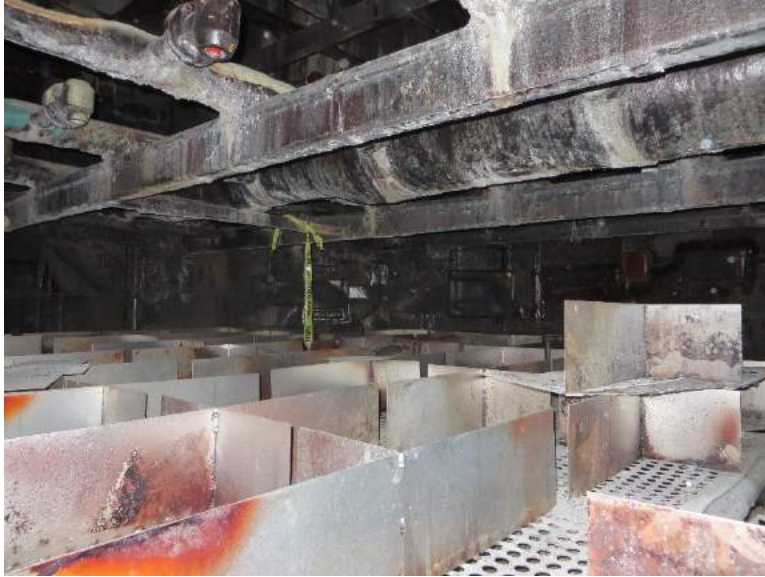
Scrubber vessels contain many different components used in the process of scrubbing SO₂ from exiting boiler flue gas. The piping and appurtenances are engulfed with the flue gas and scrubber reagent as it passes through the scrubber vessel. The atmosphere is very corrosive, which in time deteriorates all the piping, appurtenances and internal support structure.

Figure 3-9 Photo of Degraded Internal Scrubber Piping

Failure of these components can cause a forced shutdown of the scrubber tower, leaving the redundant scrubber vessel to do all the flue gas scrubbing. Each Scrubber tower is designed for 100% capacity in case this situation occurs. Both scrubbers are in varying levels of degradation, requiring replacement of components to restore reliability and capacity. Currently neither scrubber tower can be isolated because upstream and downstream dampers do not work, as previously discussed in the Scrubber Vessel Ducts section. Appendix A includes costs for piping, support structures and appurtenances in both scrubber vessels.

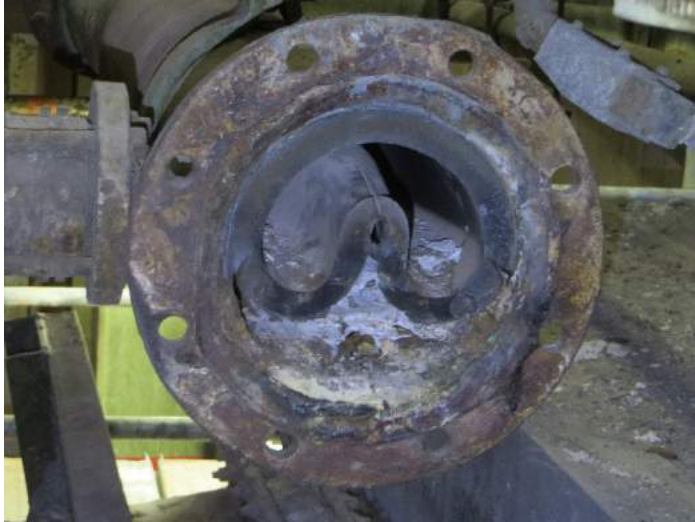
Scrubber reagent is an abrasive fluid which is recirculated from the bottom of the scrubber vessel, processed, and returned into the scrubber vessel interior piping and spray nozzles. The exterior piping is old and worn, causing frequent leaks, and in some cases the lining has separated from the pipe wall, blocking flow in the pipe.

Figure 3-10 Photo of Scrubber Recirculation Pipe Liner Separation

GHBLP has recently replaced the scrubber recirculation pumps. The large diameter piping needs to be replaced within the next 12 months to mitigate major leakage and system shutdowns. Piping and other system-related equipment replacement costs are included in Appendix A.

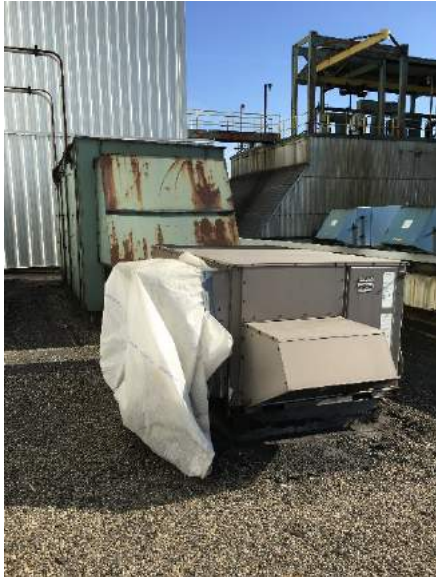
The scrubber control room and electrical switchgear room enclose the scrubber DCS control system and 4160V and 480V switchgear and MCC's respectively. The roof over this area leaks and has been temporarily repaired. An observation made when walking through the Scrubber control room and electrical equipment room was that heavy accumulations of dirt and limestone dust on the equipment and floor can be seen. Dust and dirt gets into electrical equipment connections and causes arcing and overheating, which can lead to premature failure. Dust enters the rooms through doors and other crevices. The air conditioning system is not providing adequate air pressurization to properly seal the room. The air conditioning and air handler equipment is located on the control room roof. Black & Veatch recommends the scrubber control room cracks and crevasses get sealed and the air conditioning system be checked for adequate air flow and control room pressurization within the next 6 months. If sealing the control room does not help, then the air conditioning system should be resized and replaced. If it is decided to continue to run Unit 3 past 24 months,

Figure 3-11 Photo of Scrubber Control Room Roof with Two Handler Units

replacement of the AC system should be done at the same time as the roof. Roof and air conditioning system replacement costs are included in Appendix A.

This roof should be replaced if it is decided for Unit 3 to continue to run after 24 months.
