Grand Haven Board of Light and Power

Condition Assessment for J.B. Sims Generating Station
February 14, 2018

Condition Assessment of Sims Unit 3

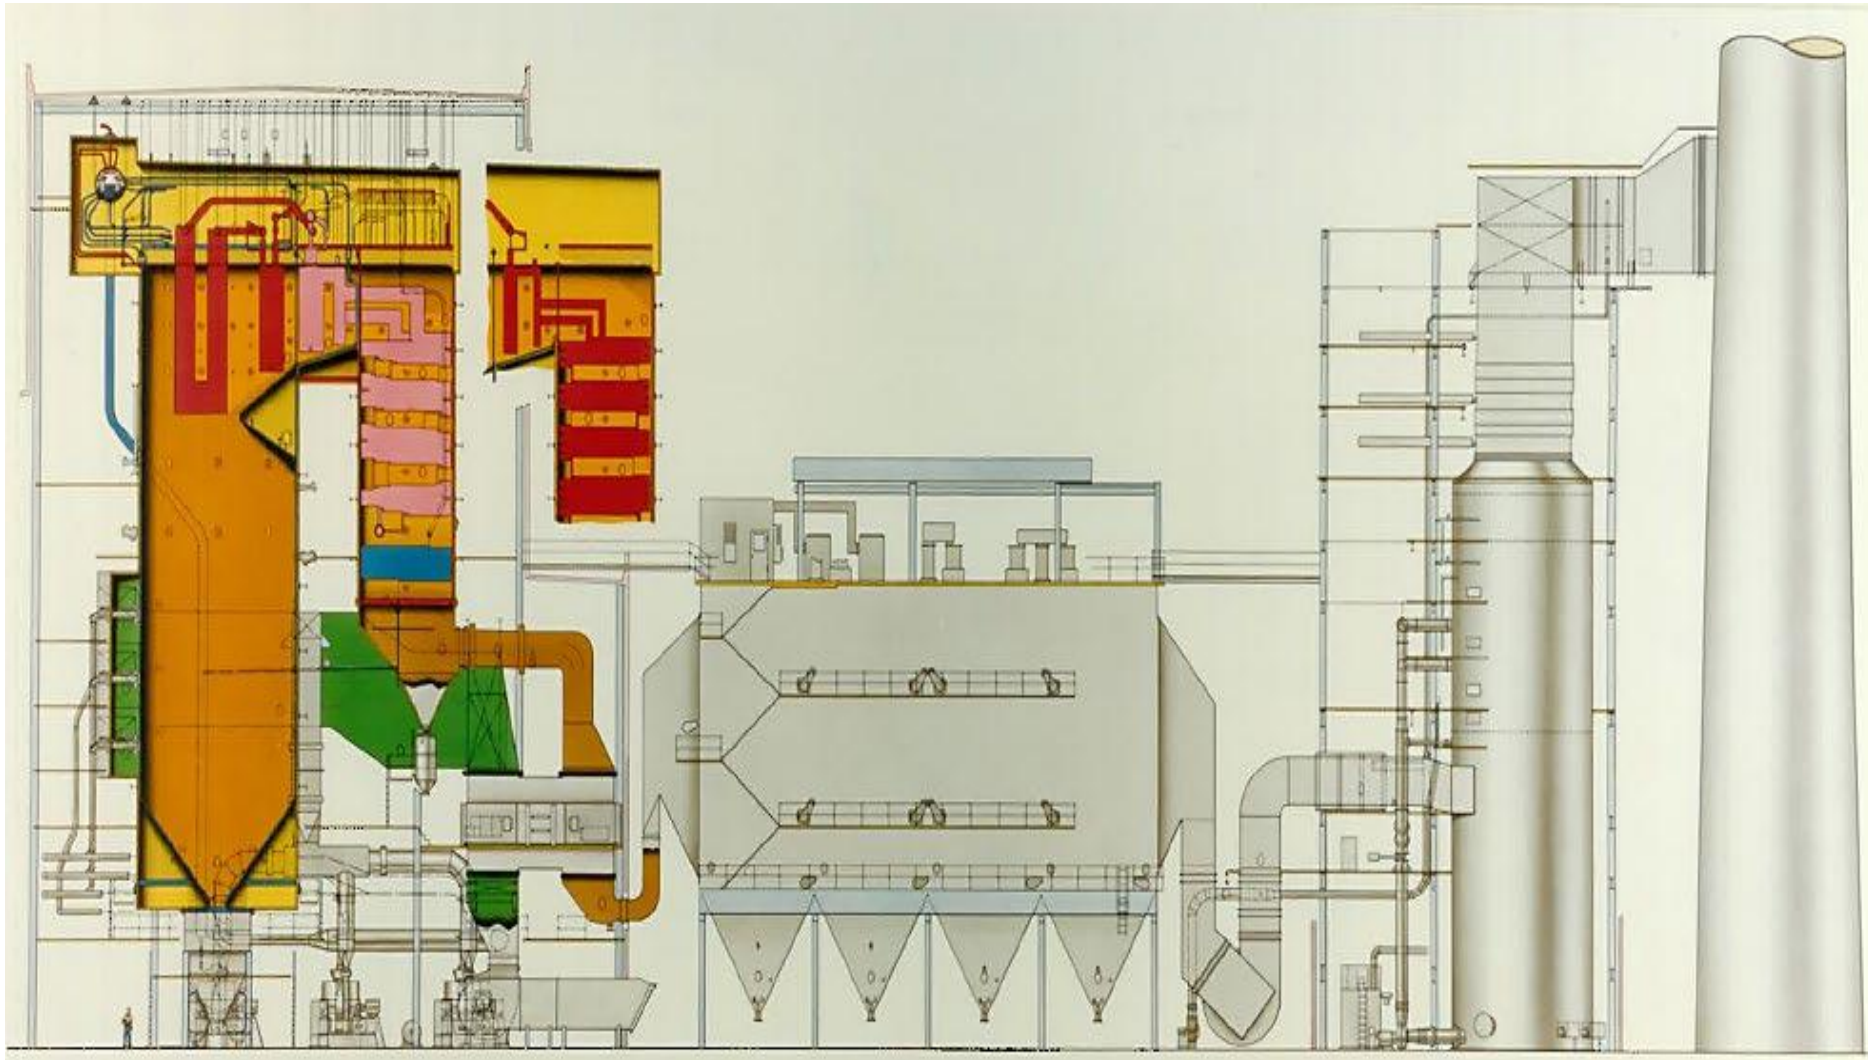
Boiler: Life Extension

Thickness testing needs to be performed on steam drum.

Platen Primary Superheater bank has reached the end of useful life. Testing results in areas identified that some tubes are 50% of original design. B&W recommends replacing tubes that are 85% of required minimum wall thickness (0.325").

Front Water Wall: Boiler tubes are showing signs of wear and require non-destructive evaluation (NDE).

North and South Water Wall: Boiler tubes are showing signs of wear and need NDE.

Low NOx burners are cracked and have reached the end of their useful life.

Coal piping to burners are recommended for replacement.

C Pulverizer needs rebuild. A & B pulverizers have already failed and been rebuilt.

Expansion joints identified as needing replacement.

Top section of Reheat bank has been identified as needing replacement.

Previous boiler inspections have identified that roof seals have exceeded their useful life and will require replacement.

Flue gas path erosion on Secondary Superheat bank has been identified. May require action in the future.

Economizer has experienced significant corrosion and erosion of outside diameter surface. Additional NDE is needed to determine life span.

Hot end baskets and seals (lifting device controls) need replacement on air heater.

Note: **Safety Alert Warning** was issued by Babcock and Wilcox in October 2017 indicating graphitization of carbon-molybdenum steels for materials SA 209 and SA335 P1. These grade steels are contained in Sims Unit 3 superheater tubes, headers, and connections. Also contained in reheat tubes. Consulting with Babcock and Wilcox (OEM) on actions that should be taken.

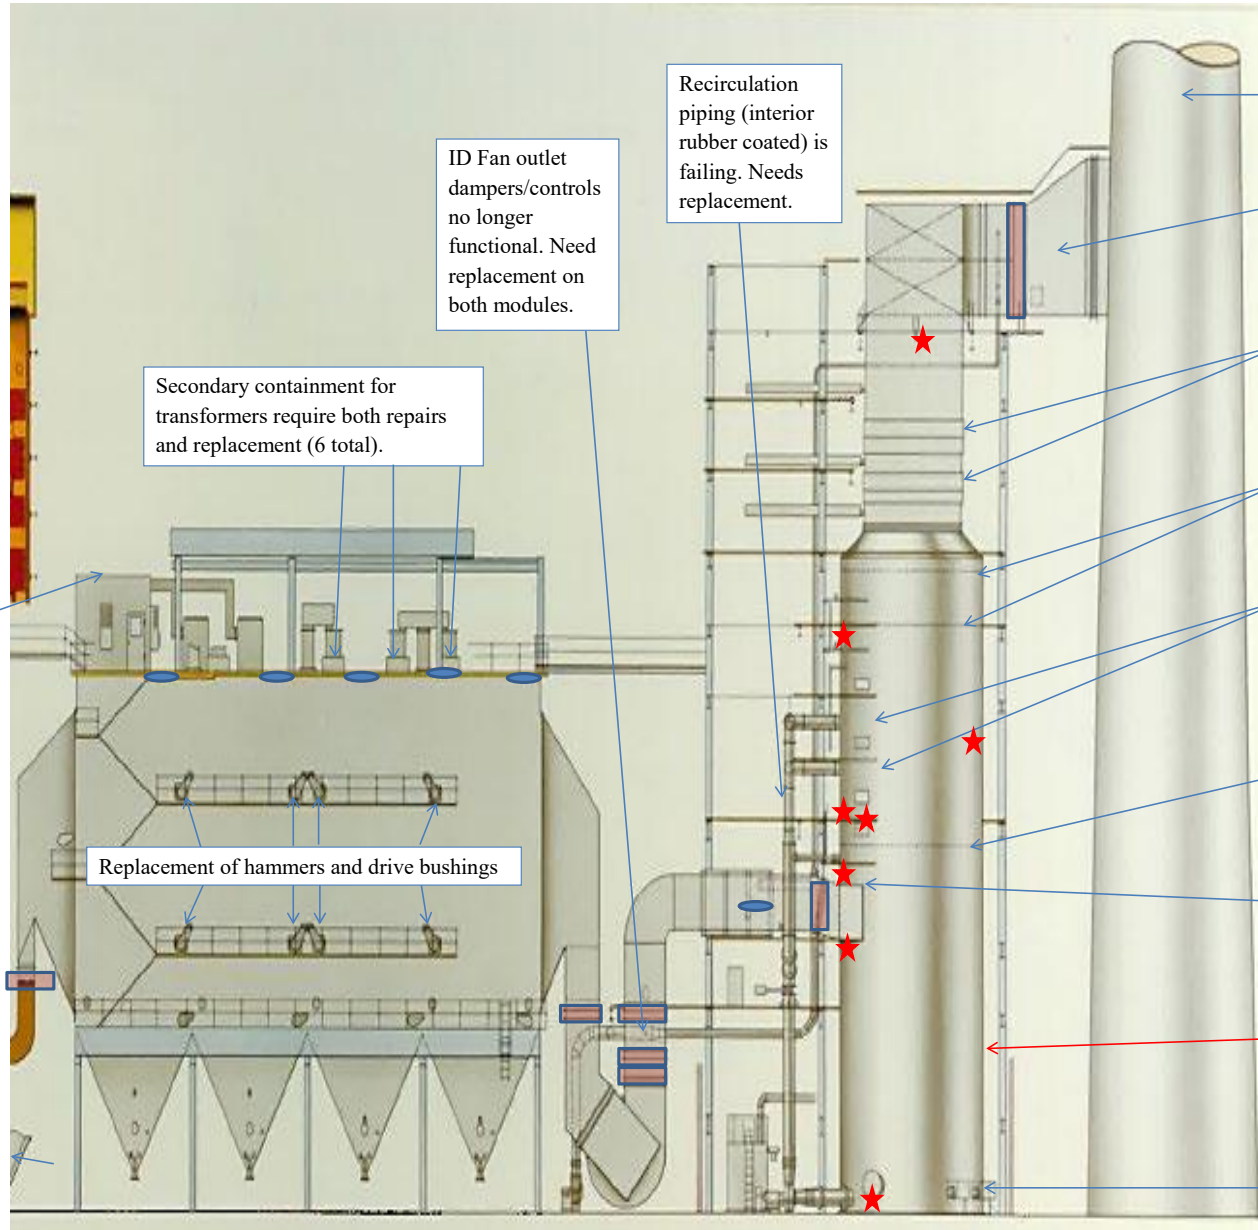
Air Emission Equipment: Life Extension

Voltage controls are obsolete and no longer supported. Controls need upgrading.

Manway access portals that need replacement for continued access (leaking and corroded).

Expansion joints identified as needing replacement.

ID Fan outlet dampers/controls no longer functional. Need replacement on both modules.

Recirculation piping (interior rubber coated) is failing. Needs replacement.

Secondary containment for transformers require both repairs and replacement (6 total).

Replacement of hammers and drive bushings

No known issues with chimney however stack inspection is scheduled for fall 2018.

Exhaust gas ductwork rotted on both modules and needs replacement.

Reheat sections on both modules past useful life. Replacement needed for continued snow melt.

Chevron primary and secondary moisture separators past useful life (damaged) on both modules. Requires replacement.

Quench spray header on module A past useful life (damaged). Requires replacement.

Absorption trays past useful life on both modules (damaged). Requires replacement.

Awning on module B requires replacement.

Both module vessels have failed in multiple locations (see red stars). Unknown as to extent of available life but at minimum modules need to be relined.

Mixers on A module have reached end of useful life. Requires replacement.

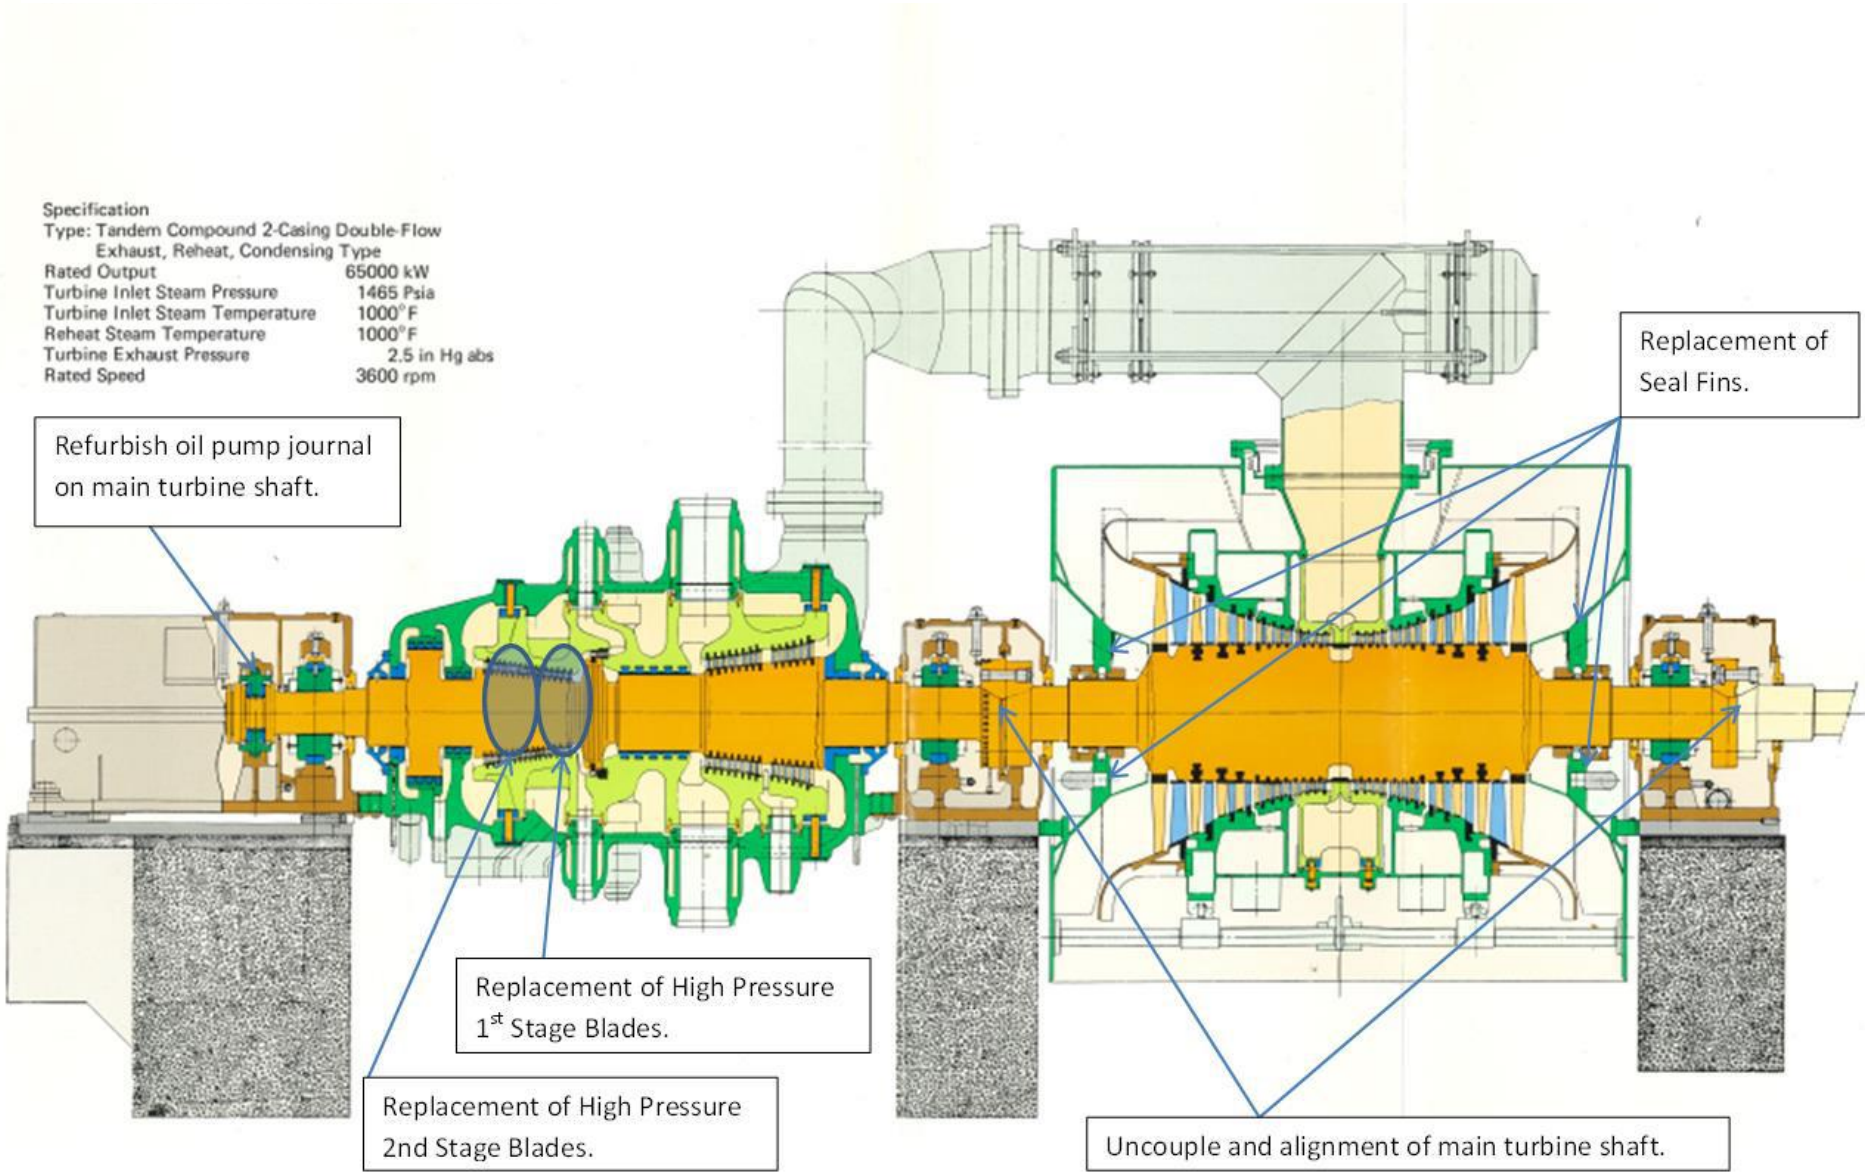
Turbine: Life Extension

Refurbish oil pump journal
on main turbine shaft.

Replacement of High Pressure
1st Stage Blades.

Replacement of High Pressure
2nd Stage Blades.

Replacement of
Seal Fins.

Uncouple and alignment of main turbine shaft.

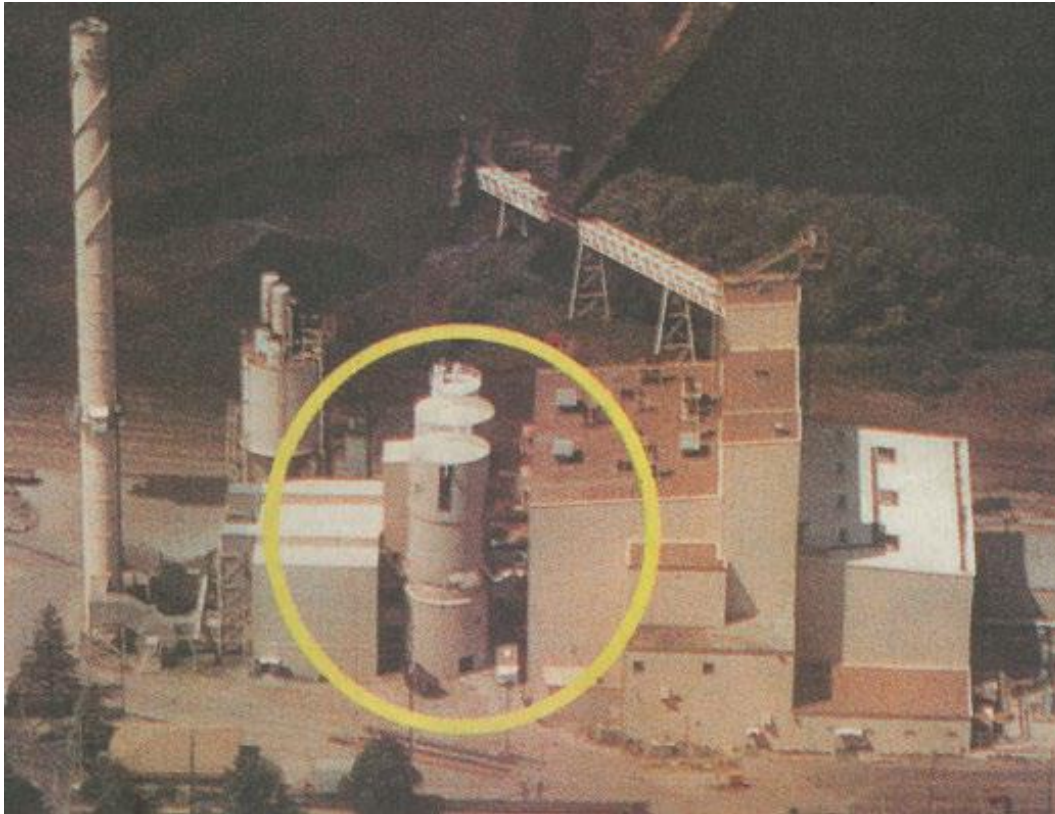
T.E.S Filer City
Manistee, MI
Scrubber Vessel Failure
(2002)

- Both vessels partially collapsed.
- Failure could have damaged surrounding structures
 - (boiler house, chimney, lime silo, fly ash silos, lime slurry tank).
- Resulted in significant amount of downtime.

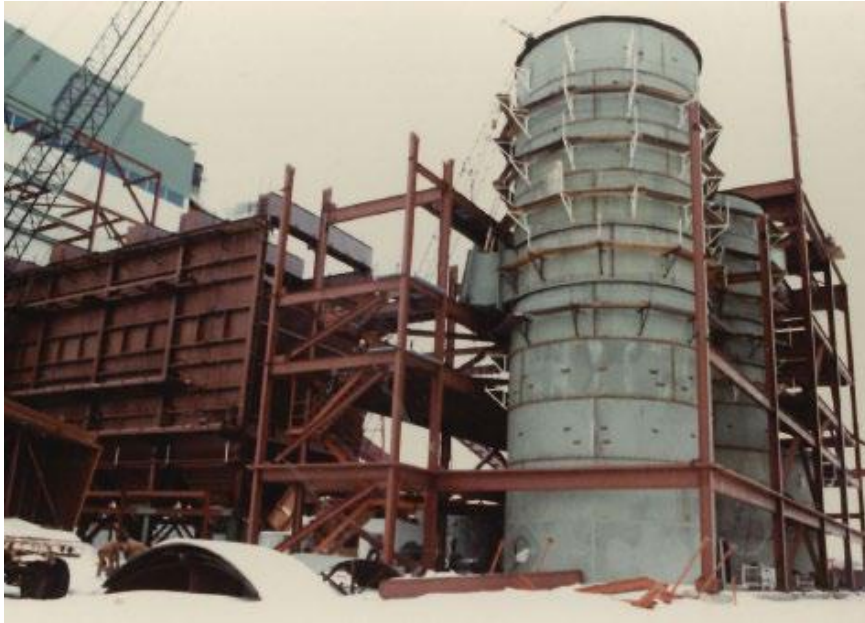
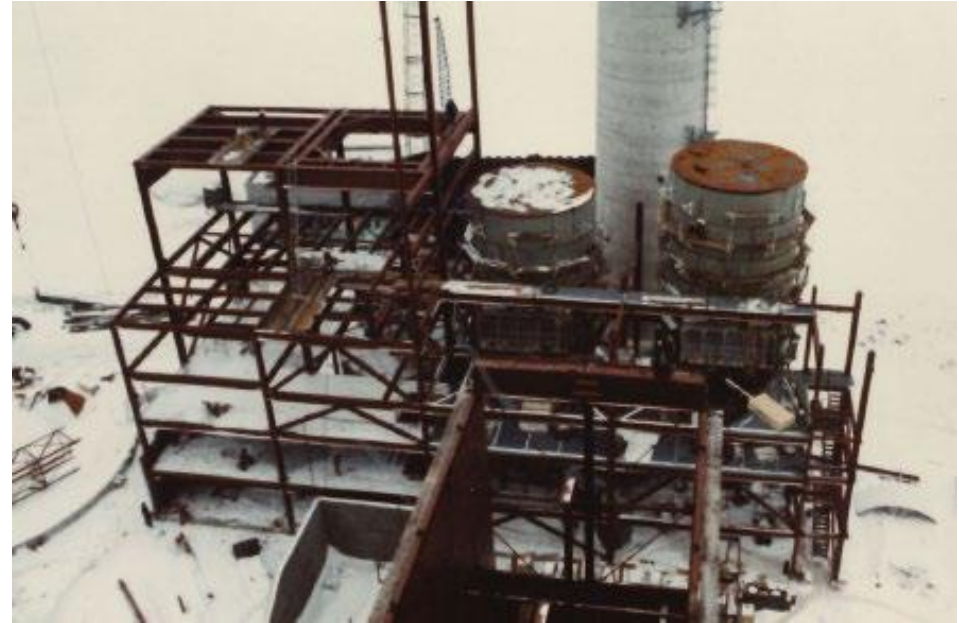
Sims – Flue Gas Scrubber

Largest Unknown in Condition Assessment

- 2012 IRP indicated that Sims vessel integrity should be evaluated.
- Cost of Flue Gas Scrubbers in 1984: \$8.1 million (equivalent to \$19.1 million in 2017).
- Problem with repairs is that vessels were erected first and housing was built around them making it difficult to make large scale repairs.
