Meeting to discuss CCRs at the
former JB Sims powerplant

Thickness of CCR at J.B. Sims Generating Station

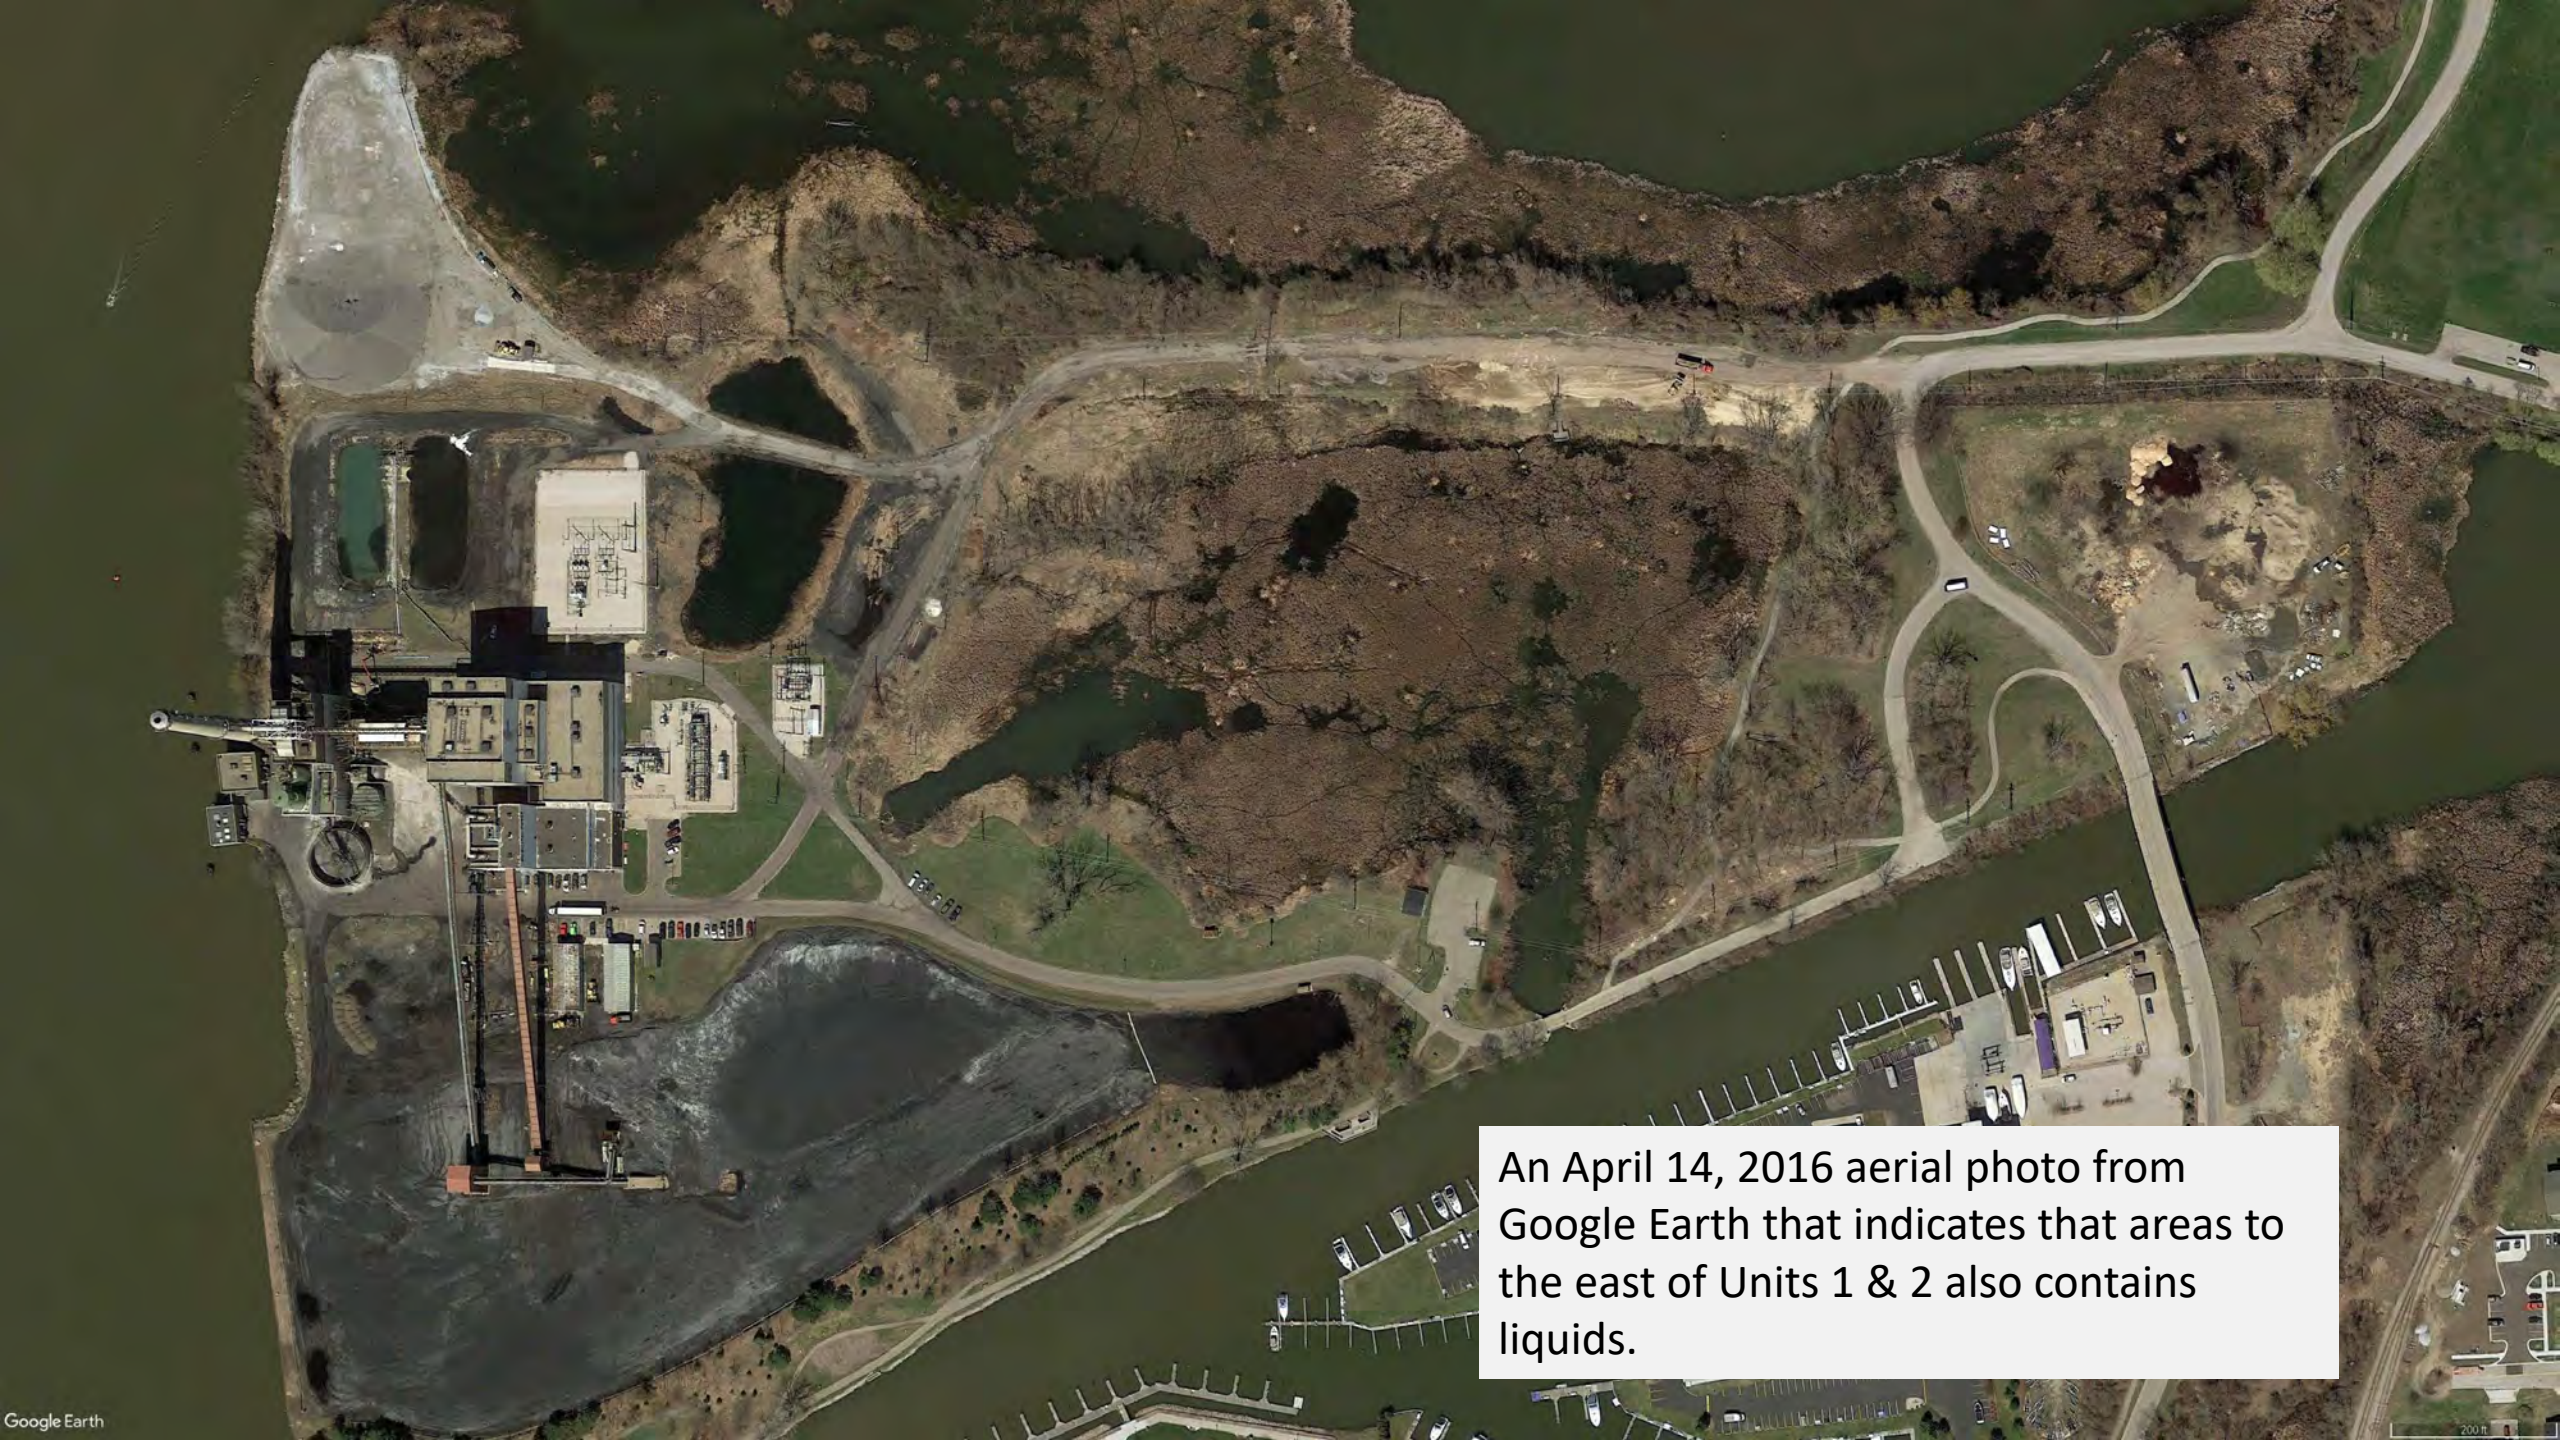
An April 14, 2016 aerial photo from Google Earth that indicates that areas to the east of Units 1 & 2 also contains liquids.
