Project No. 18113500

UNIT 3 CLOSURE CERTIFICATION DENIAL, J.B. SIMS GENERATING STATION – COMMENT RESPONSE

Subject: **Calibration Curve for J B Sims Unit 3 Pond CCR Removal Colorimetry Samples**

**Report of Colorimetry and Microscopical Analysis of CCR Content
JB Sims Generating Plant, Grand Haven, Michigan**

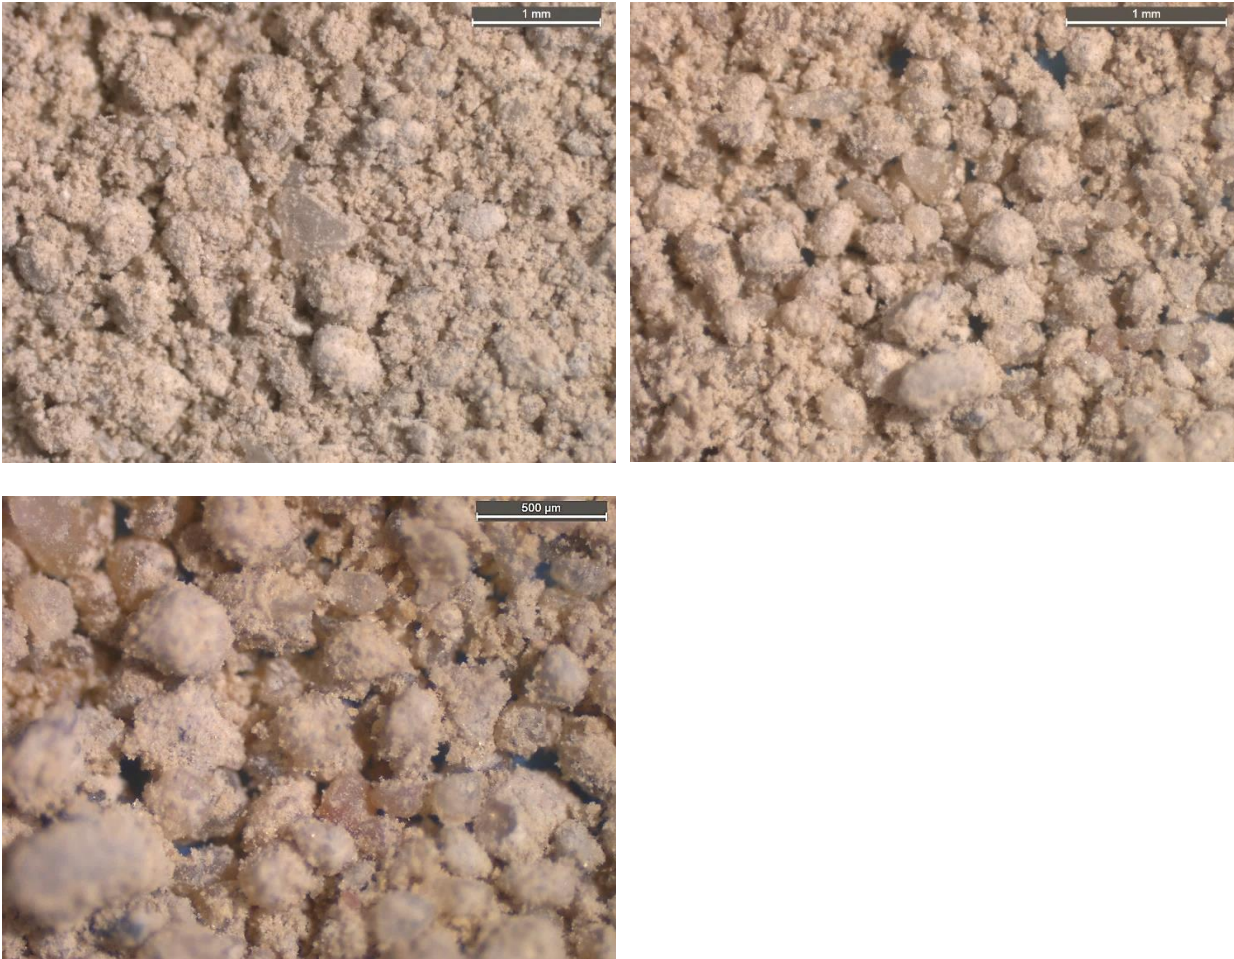
Fig. 2 Granular Material in Clay Soil Sample U3E-CS-03. The soil sample consists of powder and granules of quartz, feldspar, and granite. The area photographed was intentionally selected to illustrate the granular particles and does not represent the overall abundance of these particles in clay soil sample.

The appearance of the processed clay composite soil is shown in Fig. 1. Sample U3E-CS-03, shown in Fig. 2, contains granular sand particles that may be a site contaminant. The presence of quartz does not noticeably affect the color measurement of this sample and the presence of the sand particles was diluted by combining this sample with other clay soil samples. The appearance of the as-received CCR is shown in Fig. 3; the as-received appearance best illustrates the characteristics of the material.

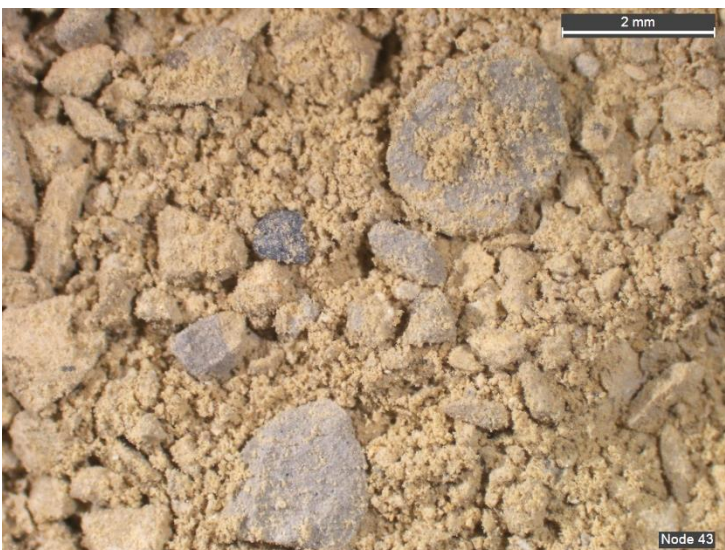
Fig. 2 Node 43 – The dark particle is CCR. The sample mainly consists of yellow clay and pale gray clay.

Quantities of CCR determined by microscopy are given in column 3 of Table 1. Two samples, Node 3 and Node 28, determined by colorimetry to have 0% CCR, were verified by microscopy. Samples determined by colorimetry to have greater than 5% CCR (Nodes 18, 43, 46, and 81) were examined microscopically and confirmed to contain more than 5% CCR. The amount of CCR in sample Node 43 determined by microscopy is 4 to 5% by volume. Typical CCR particles in these samples are illustrated in Figs. 1 through 4.

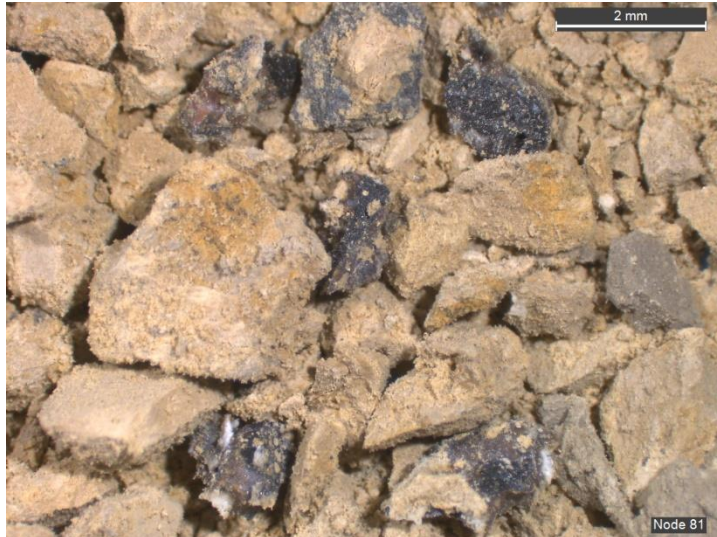
Fig. 4 Node 81 – Dark particles are CCR. The sample mainly consist of buff, yellow, and pale gray clay.

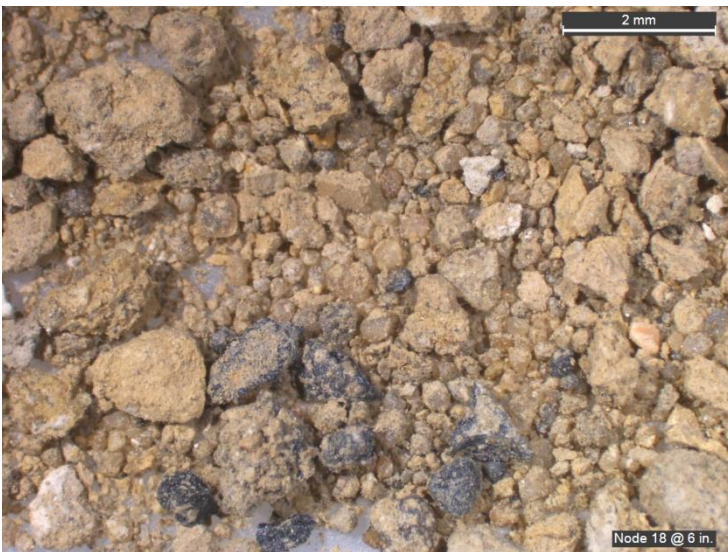
Fig. 5 Node 18 6 in. – Dark particles are CCR. The sample mainly consists of yellow clay and pale gray clay.

Results of Re-Test: The re-test samples were analyzed by colorimetry and microscopy. Node 18 @ 6 in. contains more than 5% CCR by both methods. Node 18 @ 12 in. contains less than 2% CCR. Node 81 @ 6 in. contains less than 5% CCR by both methods; however, Node 81 @ 12 in. contains 5.5% CCR by colorimetry and 3 to 4% CCR by microscopy.

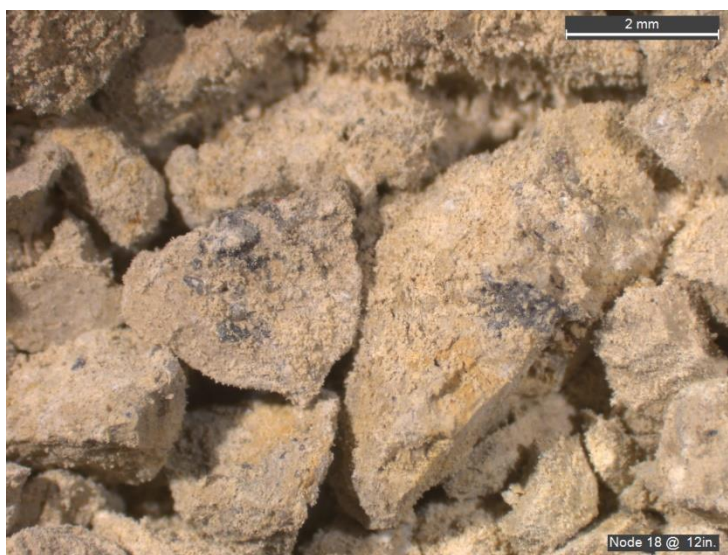
Fig. 6 Node 18 12 in. – Dark patches are CCR embedded in clay.

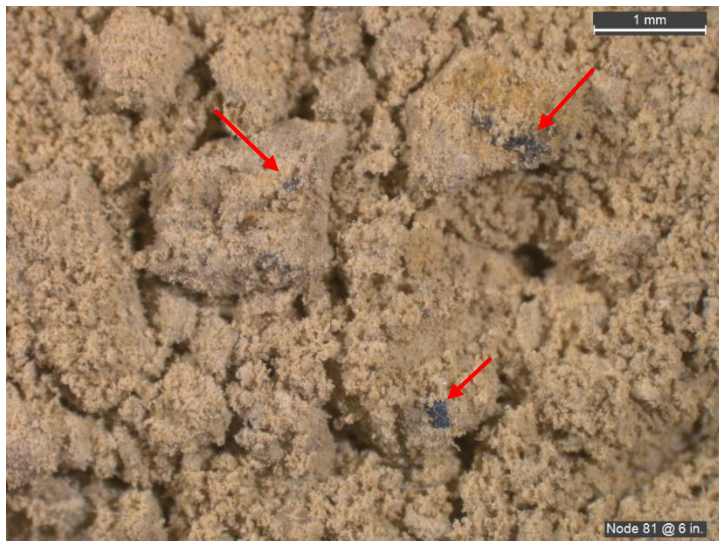
Fig. 12 Node 81 6 in. – Dark patches are CCR embedded in clay. The sample mainly consists of clay.
