STATE OF MICHIGAN  
DEPARTMENT OF  
ENVIRONMENT, GREAT LAKES, AND ENERGY  
GRAND RAPIDS DISTRICT OFFICE

August 26, 2021

SUBJECT: Unit 3 Clay Liner Additional Information

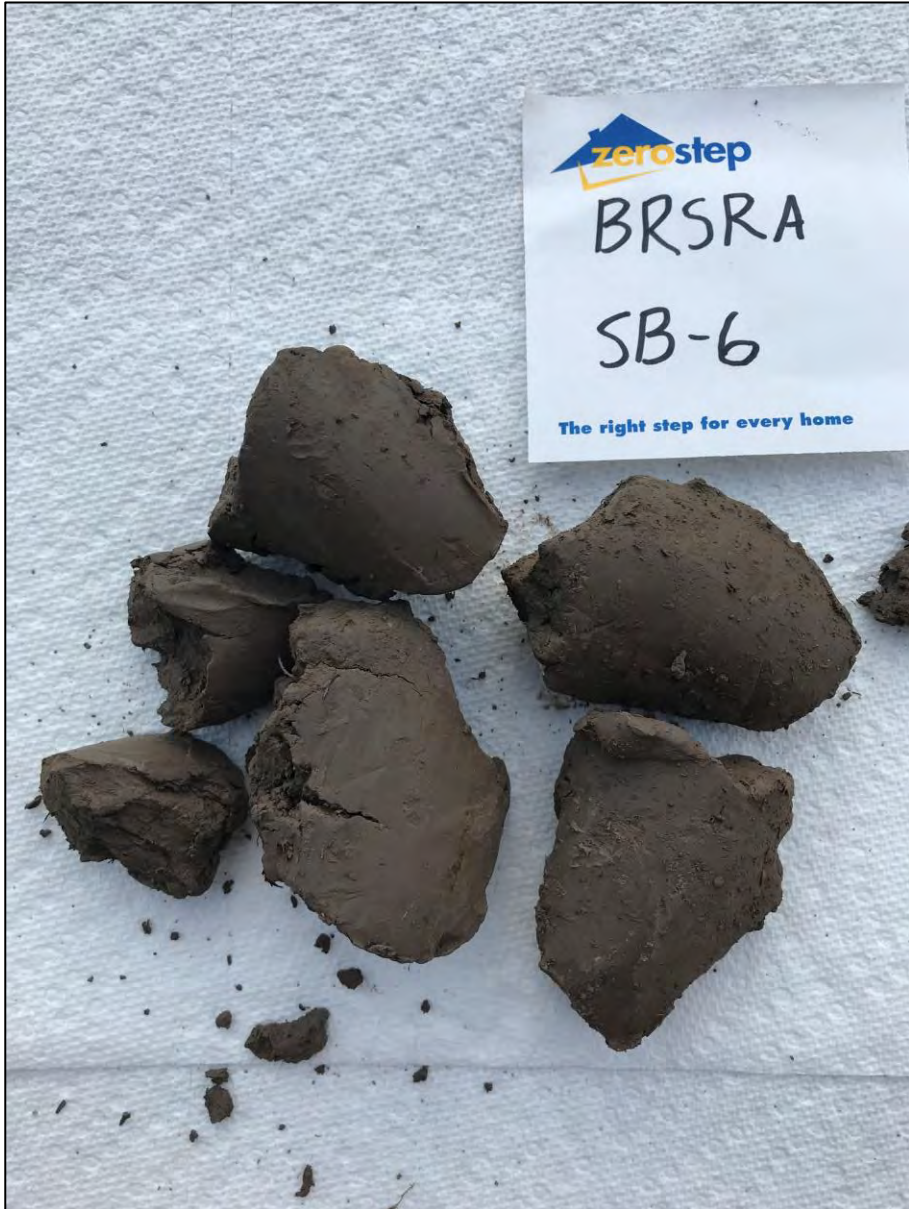
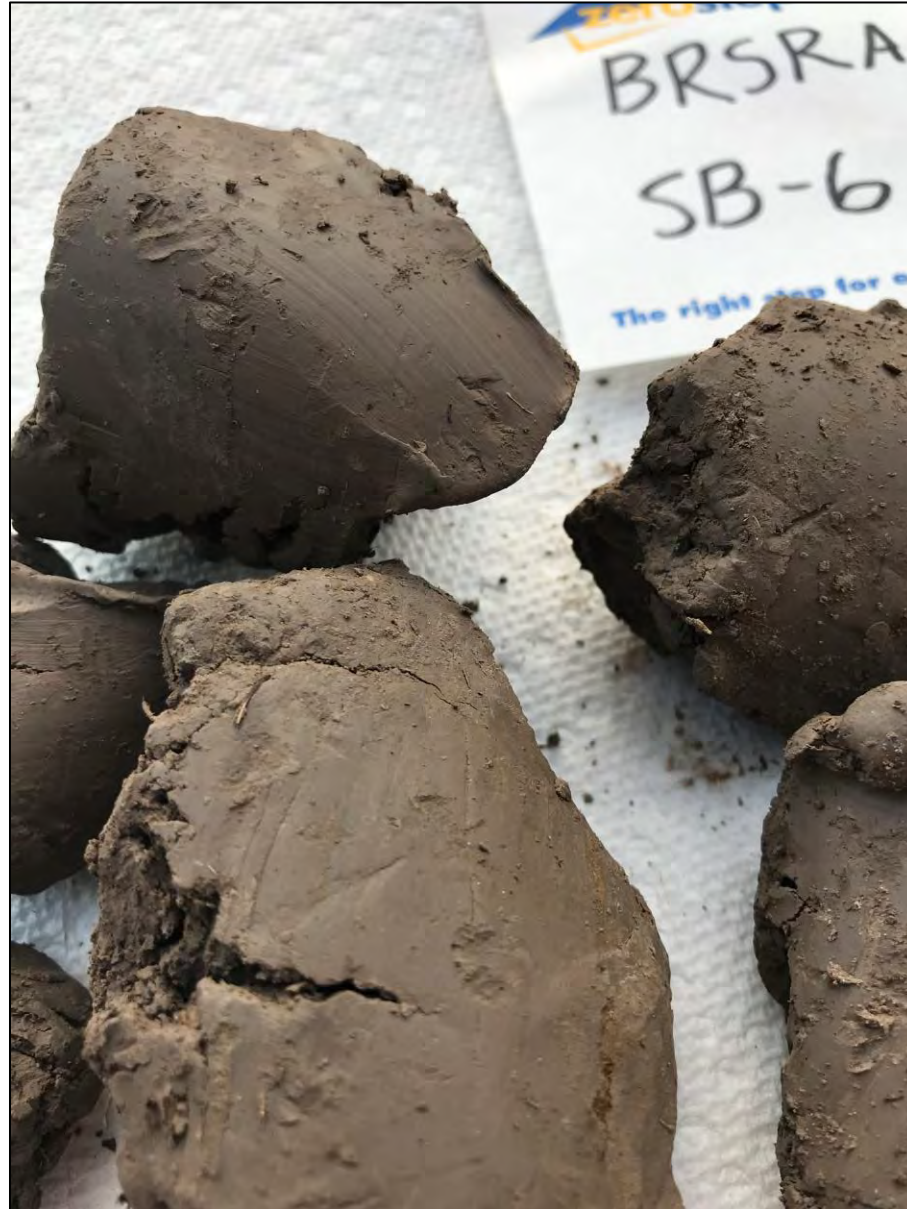
## SB-6 Confirmatory Sample Location

Sample Location SB-6:  
Clay with few silt, fine  
gravel and fine sand.  
Grey, some mottling  
present in soil, moist,  
some rooty material,  
firm.

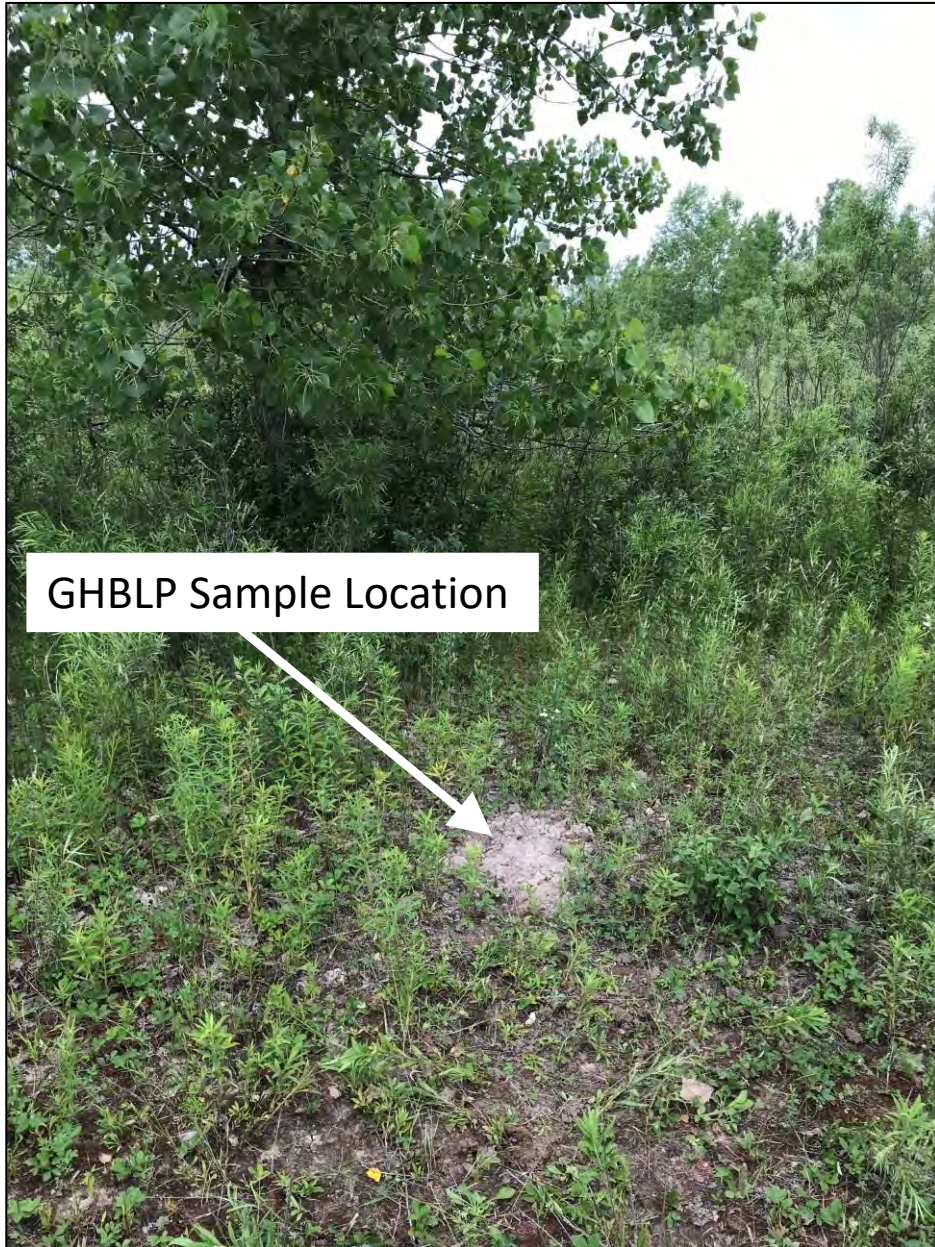
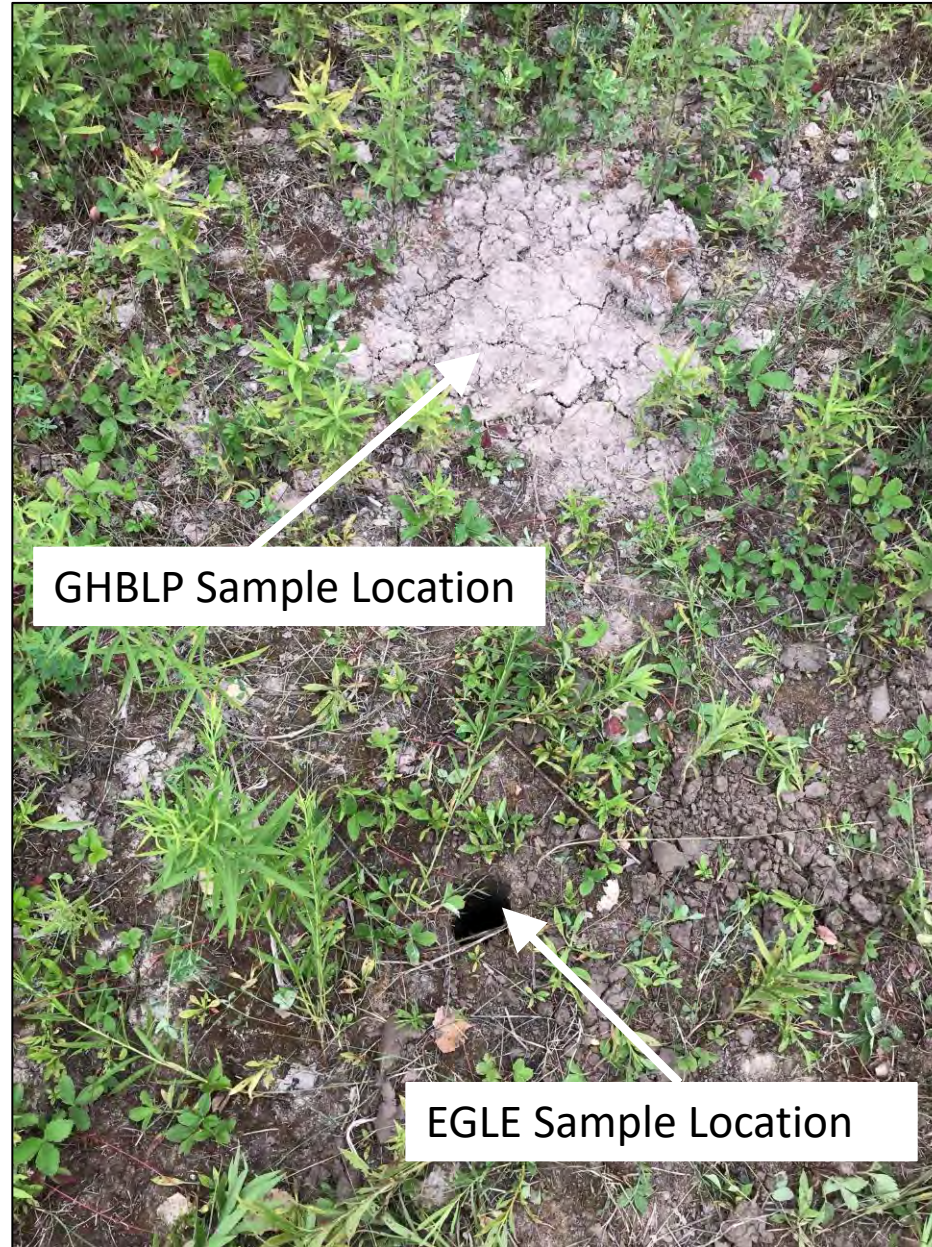
## SB-6 Confirmatory Sample Location

Sample Location SB-6:  
Sample was collected  
within 3 feet of GHBLP  
location and collected  
6-12" below ground  
surface

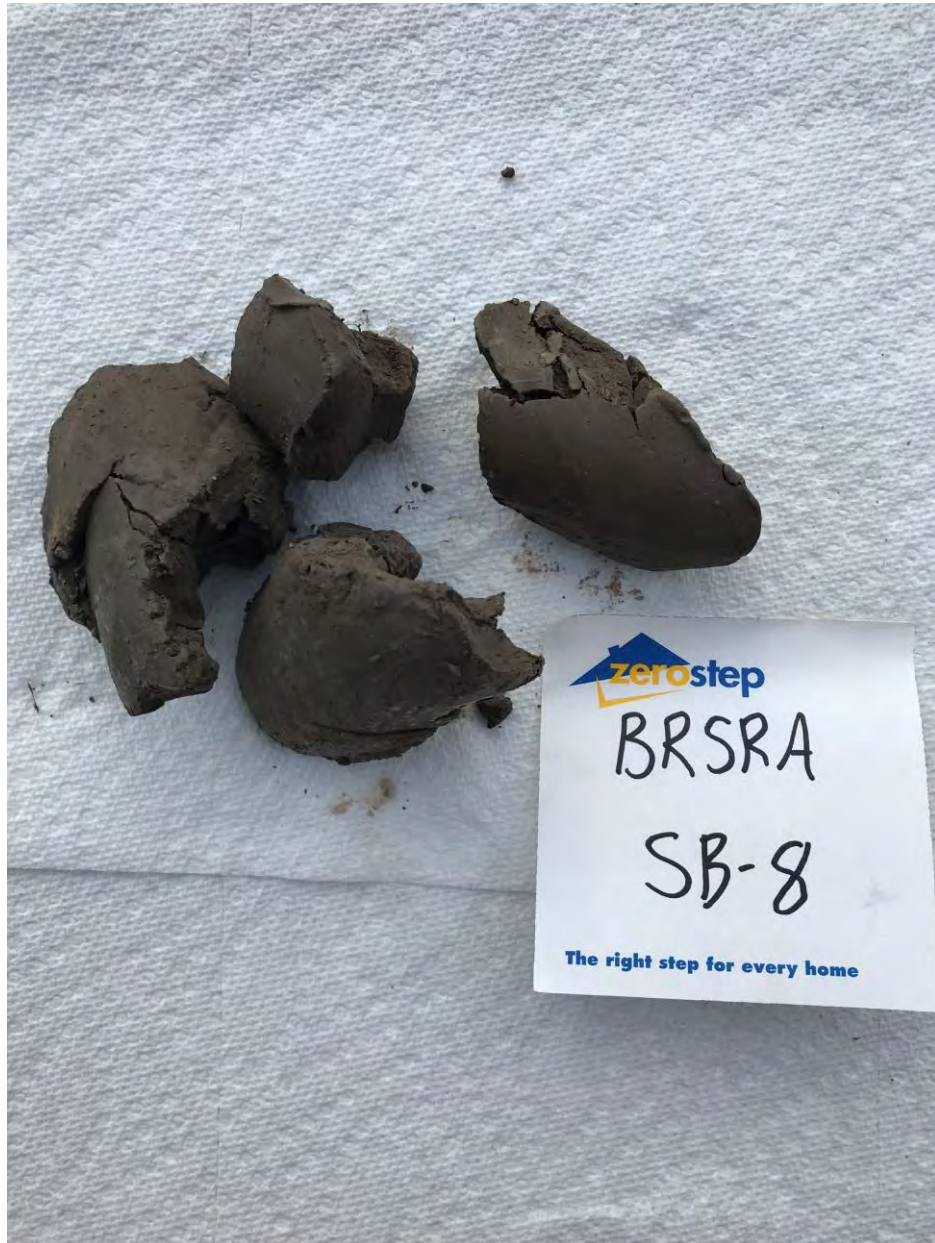
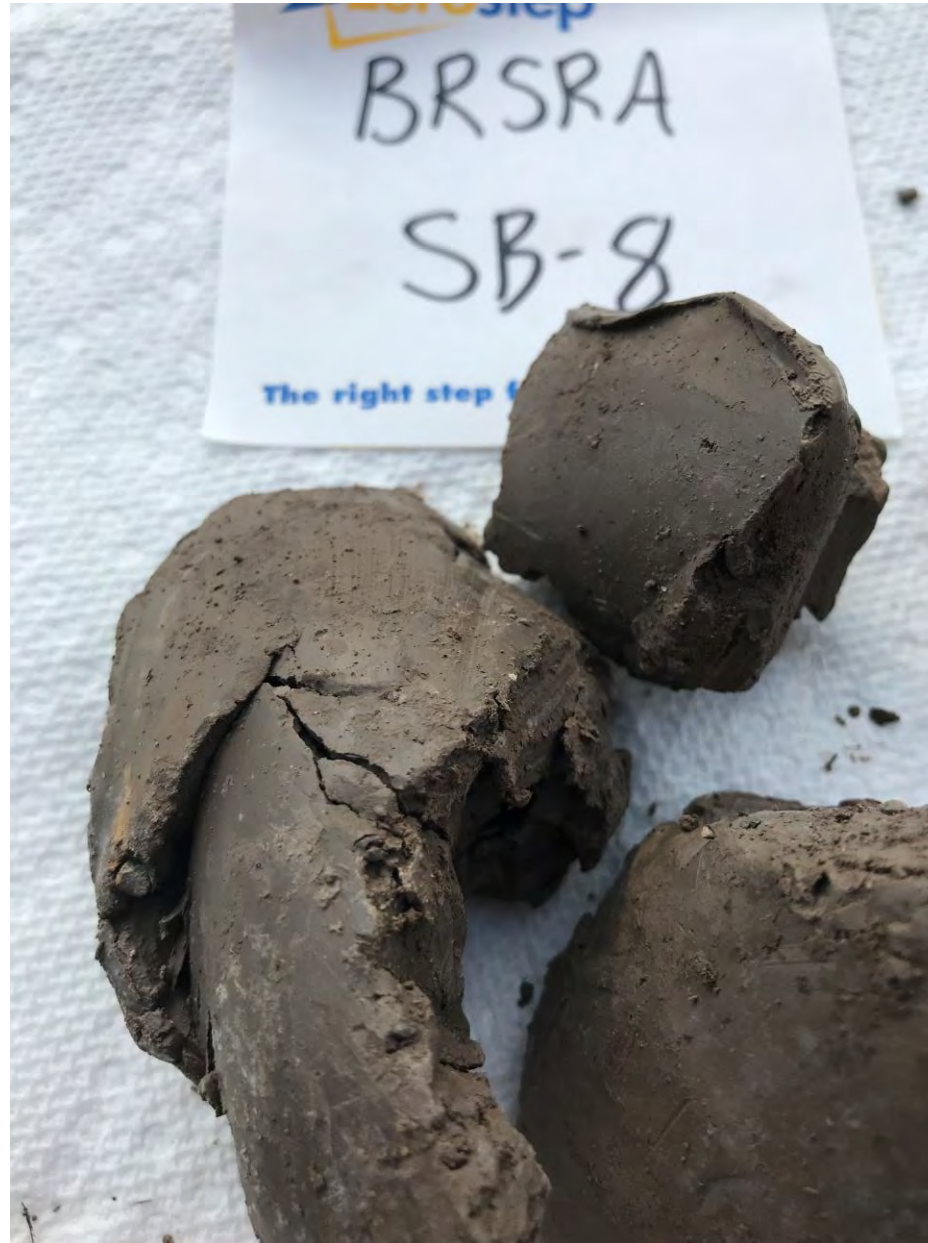
## SB-8 Confirmatory Sample Location

Sample Location SB-8:  
Clay with few silt, fine  
gravel and fine sand.  
Grey, somewhat friable,  
rooty material,  
Dense/hard

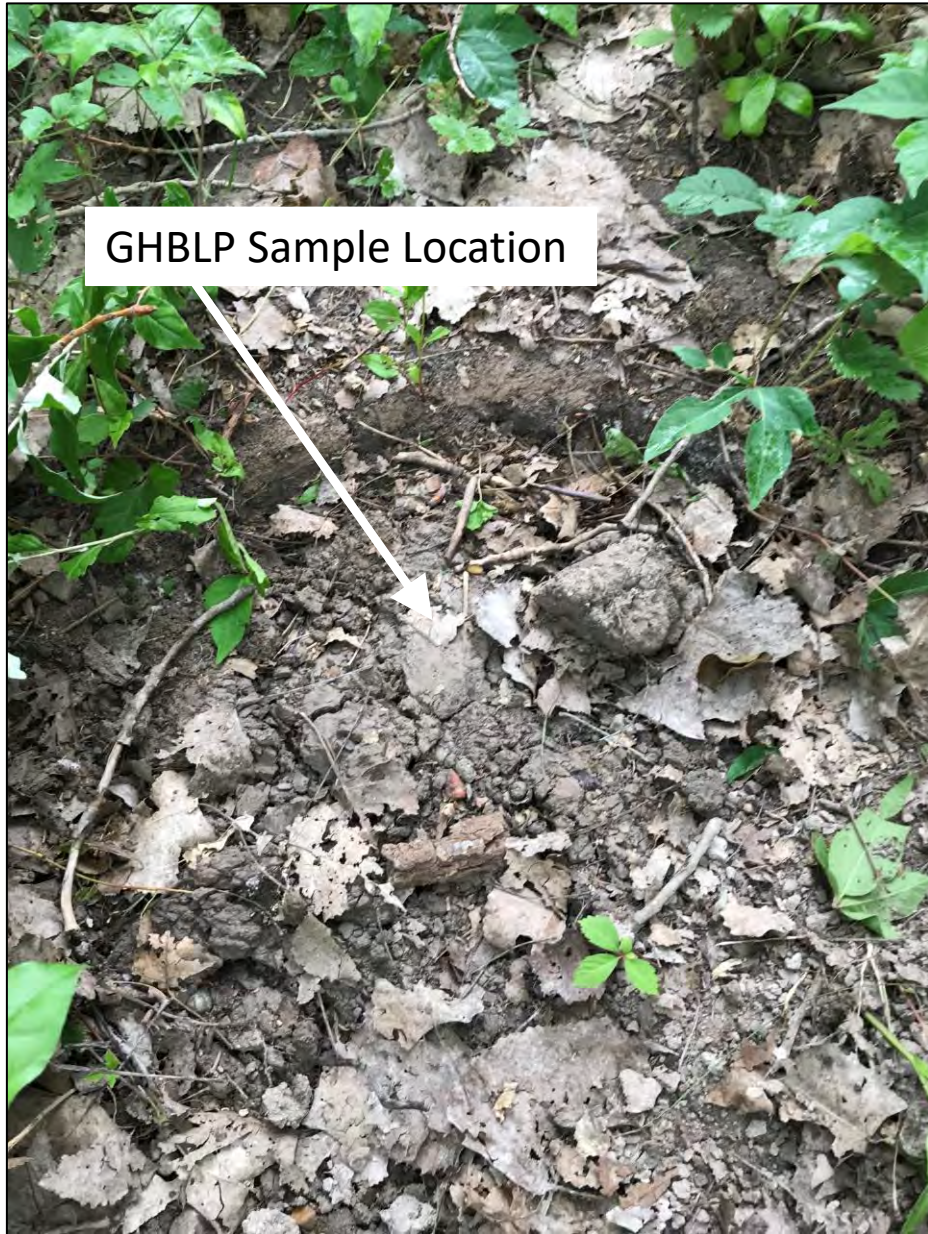
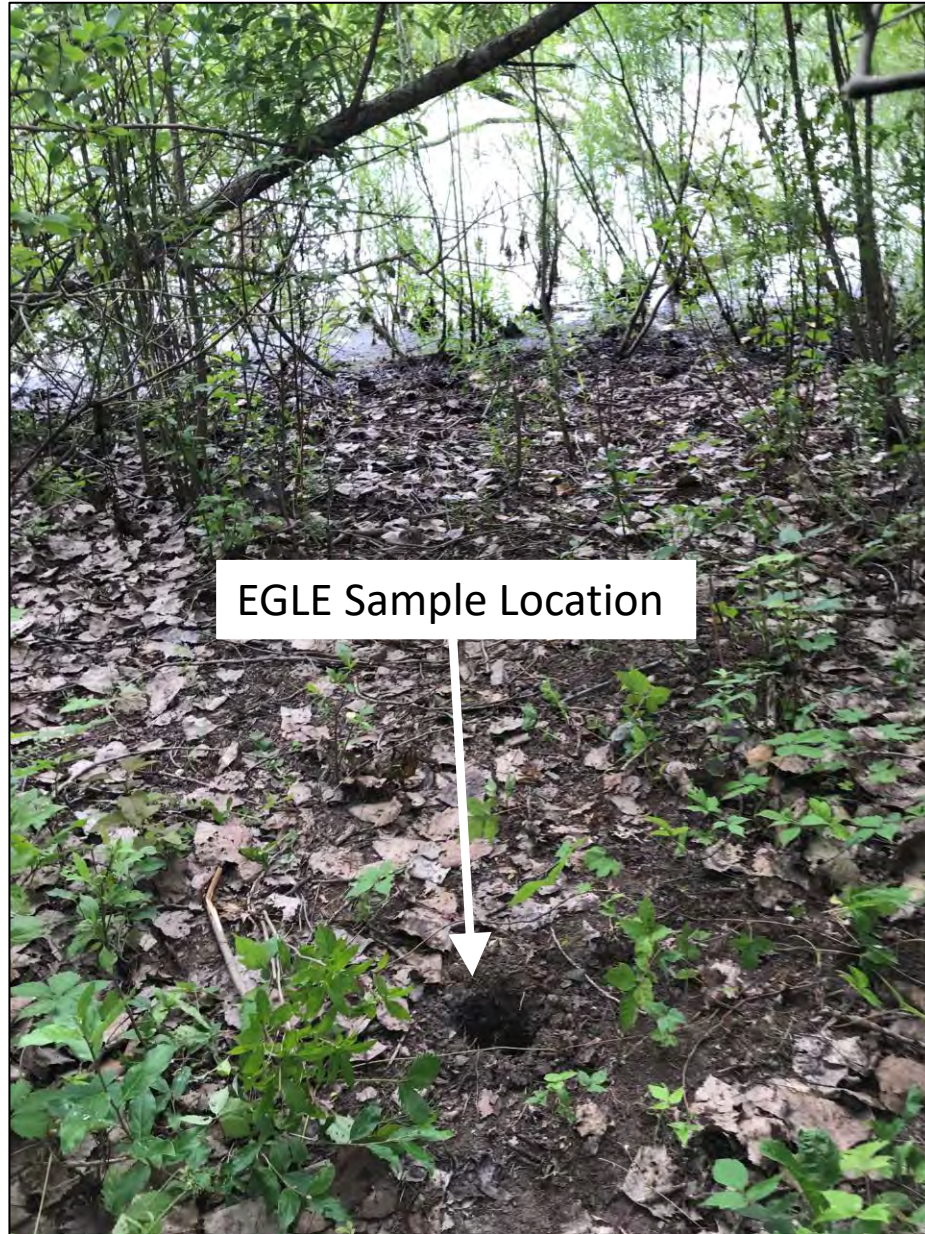
## SB-8 Confirmatory Sample Location

Sample Location SB-8: Sample was collected within 3 feet of GHBLP location and collected 6-12" below ground surface. Sample was located 3' closer to waters edge than GHBLP sample location.

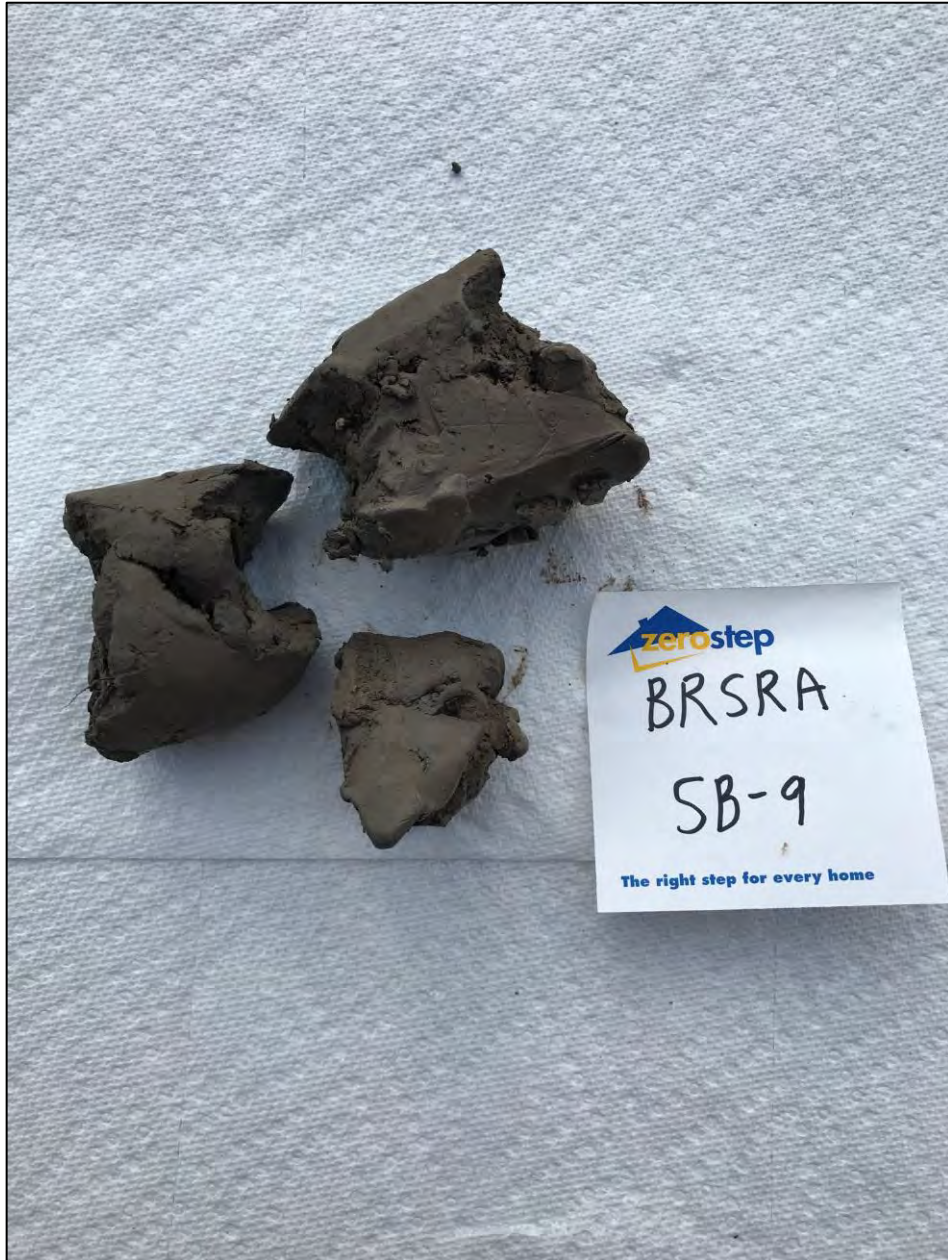
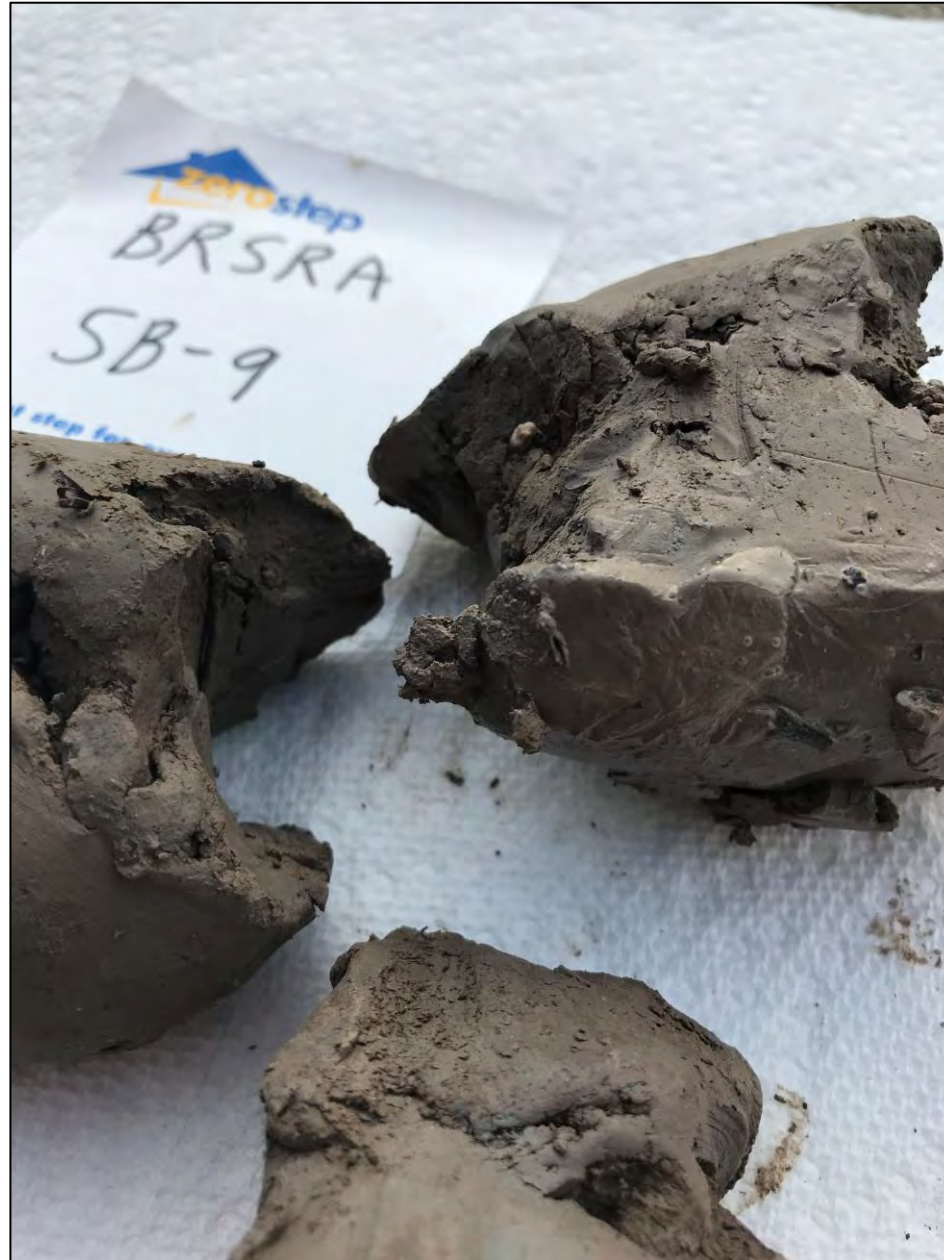
## SB-9 Confirmatory Sample Location

Sample Location SB-9:  
Clay with few silt, fine  
gravel and fine sand.  
Grey, somewhat friable,  
rooty material,  
Dense/hard

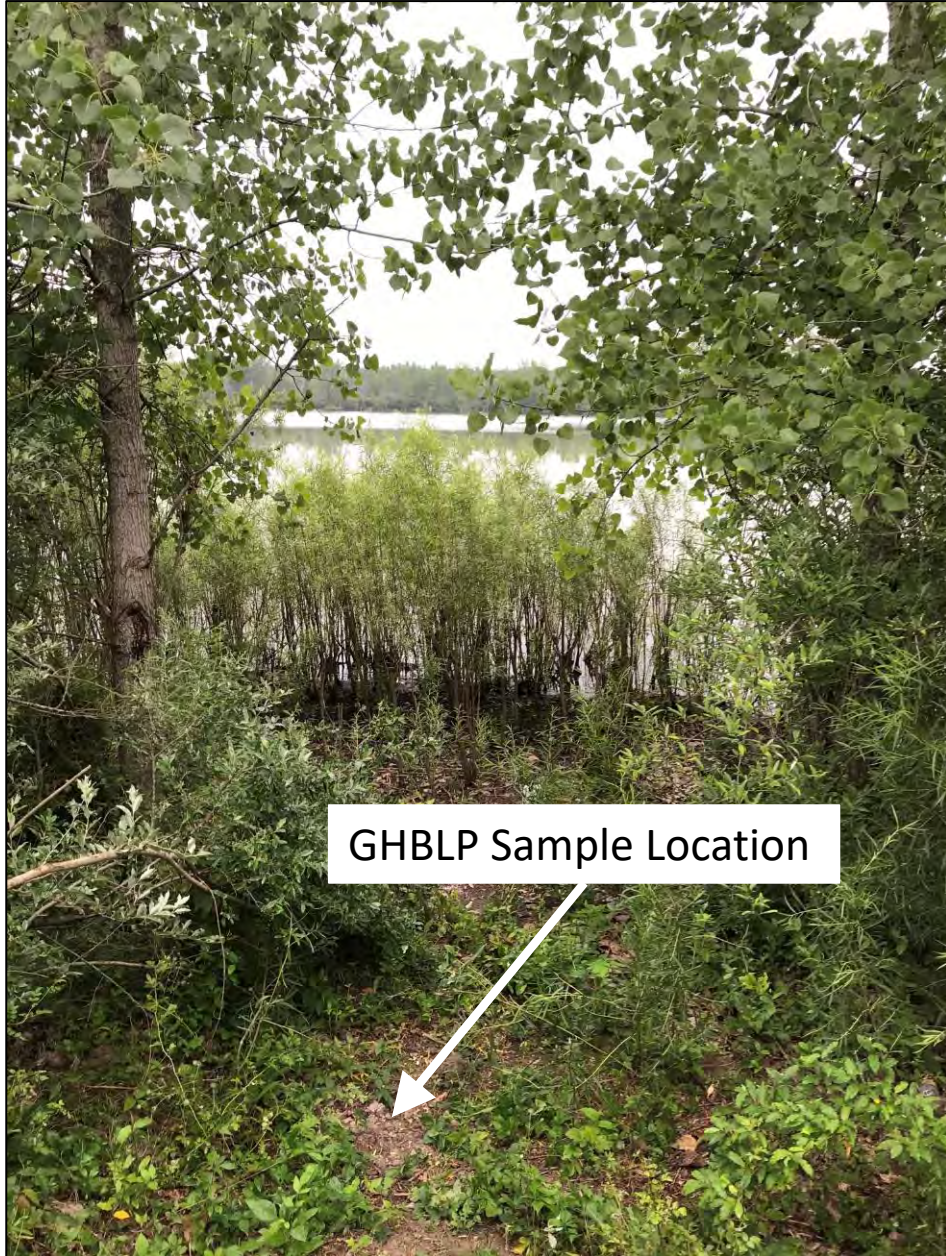
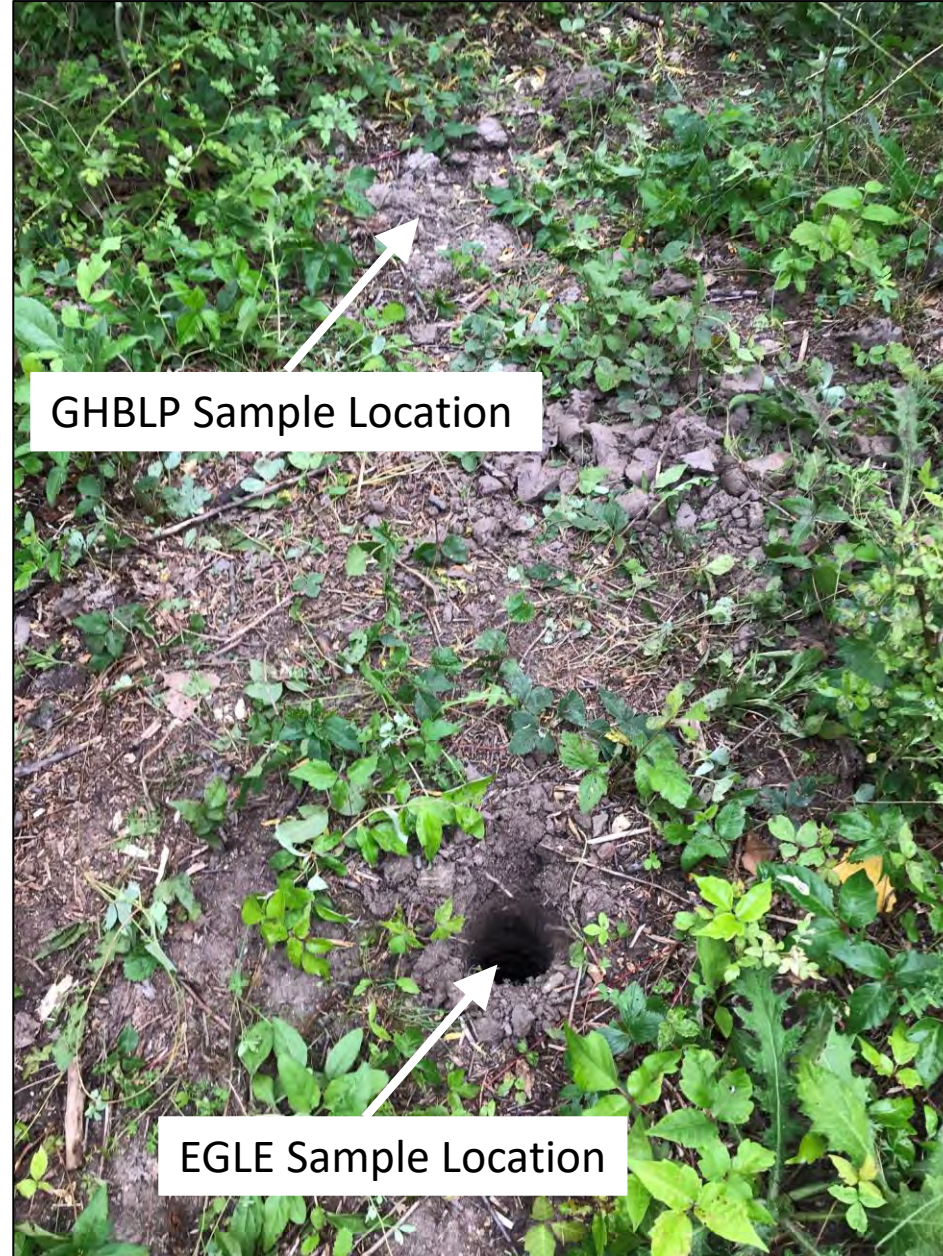
## SB-9 Confirmatory Sample Location

Sample Location SB-9:  
Sample was collected  
within 3 feet of GHBLP  
location and collected 6-  
12" below ground  
surface.

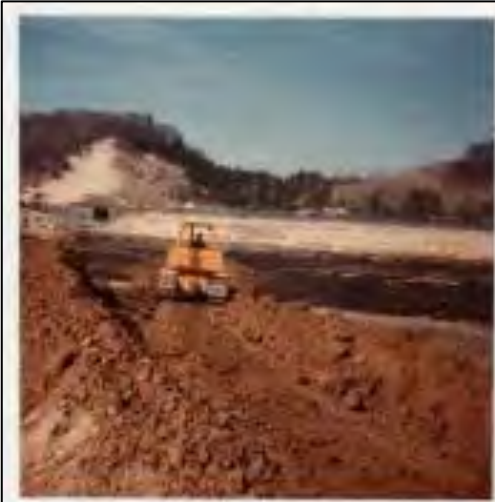
First, the Unit 3 clay observed at the JB Sims site and during installation in 1983 is observed to be predominantly brown in color (Figure 1). The clay observed in the report and from the EGLE site visit at the Bass River Recreation area noted the clay was predominantly gray in color.

7. Spreading the initial lift of clay onto the southwest quadrant of the ash ponds.

Brown clay when Unit 3 construction just started in early 80s

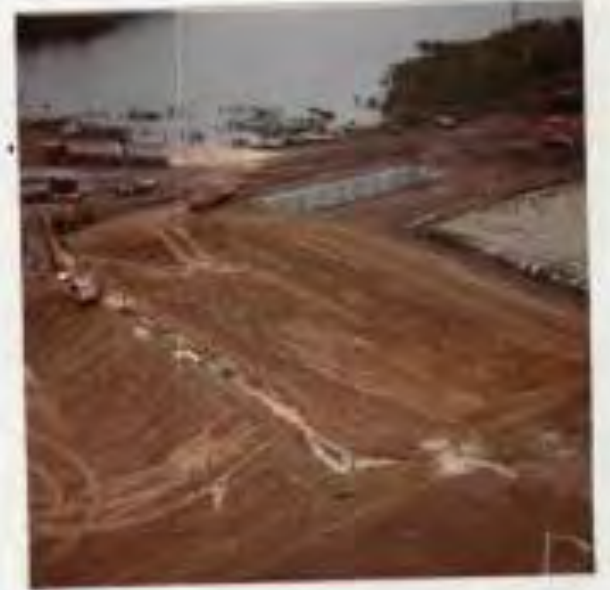
67. East pond construction progress. Late June

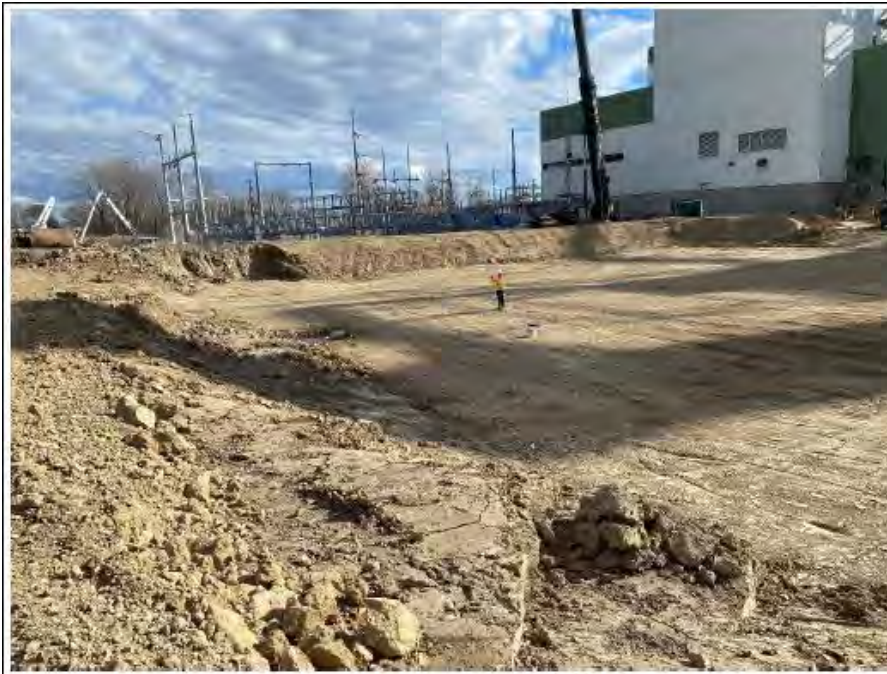
Brown clay at Unit 3, exposed during ash removal current day.

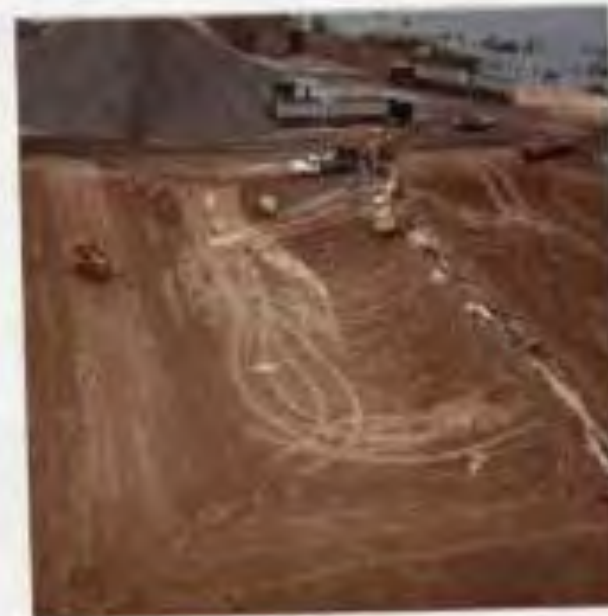
68. West pond construction progress. Late June

Brown clay when construction at Unit 3 was close to completion in early 80s

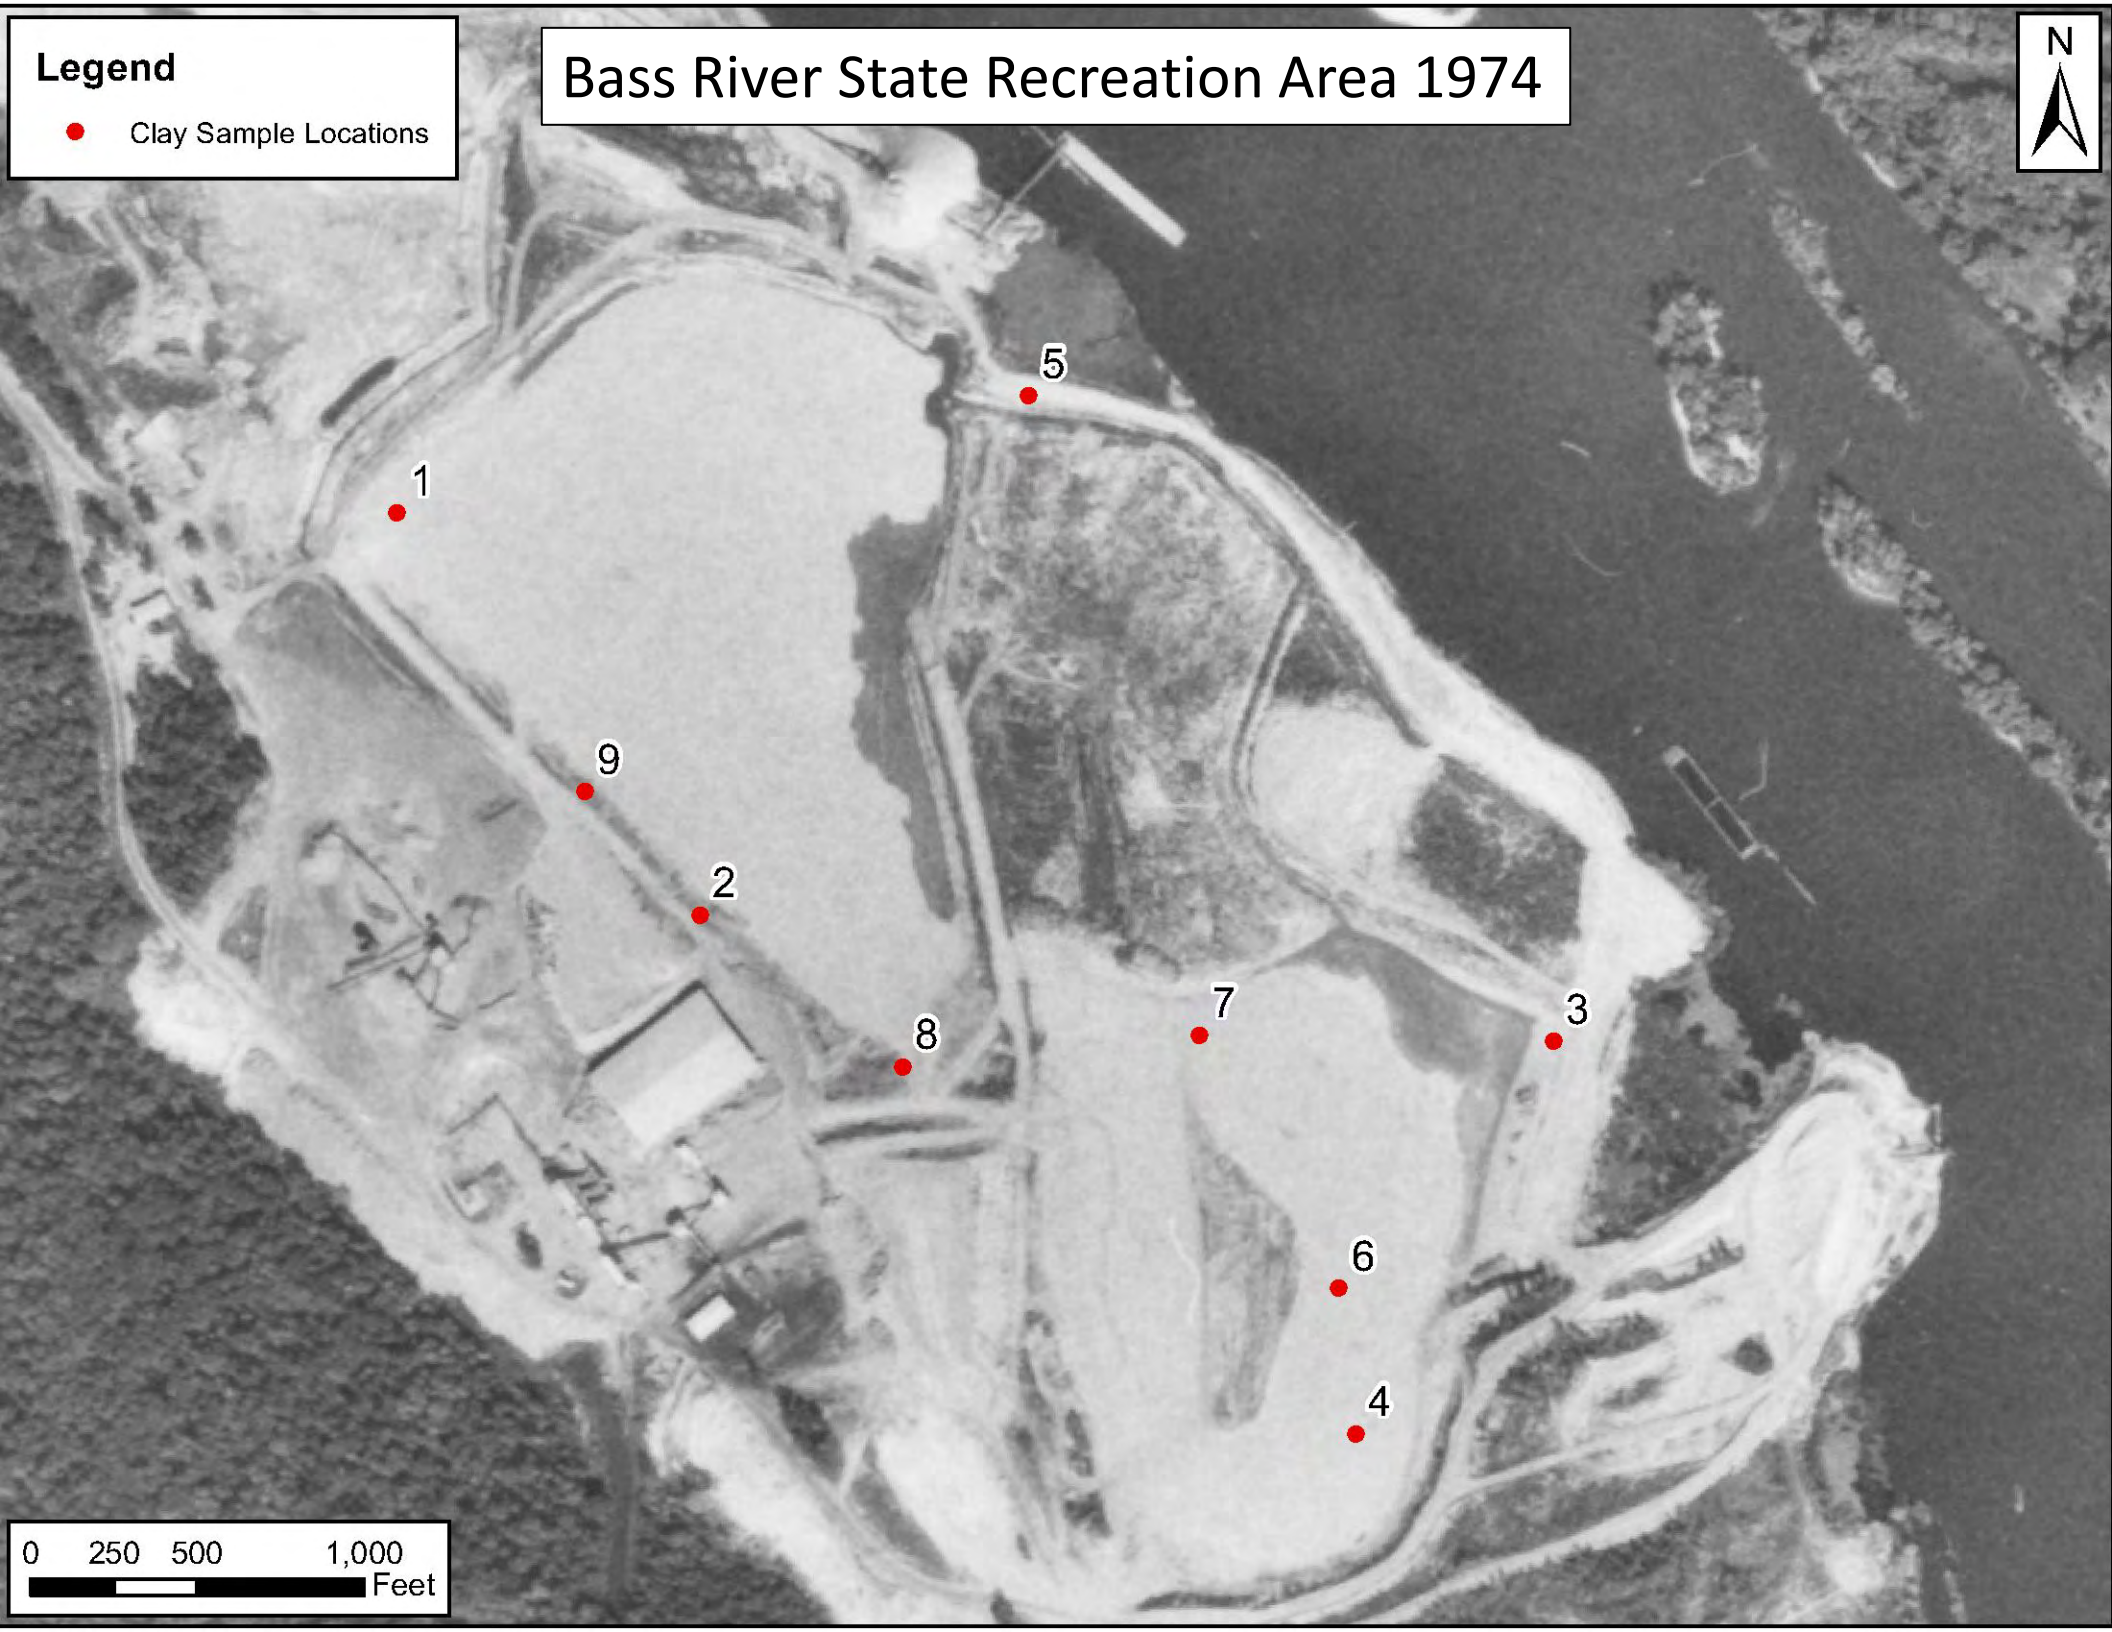
**Bass River State Recreation Area 1974**

Second, EGLE reviewed historical aerial imagery of the site before and after construction of the Unit 3 impoundments (Figure 2). The 1974 aerial photo (pre-Unit 3 construction) and 1993 aerial photo (post-Unit 3 construction) do not appear drastically different. The clay borrow area does not appear to have been excavated any further than its current day boundaries since 1974. EGLE questions if the clay material may have been mined from a different depth or someplace different on the site. EGLE requests if GHBLP could provide more information to where on the site the clay may have been sourced.
