Grand Haven Board of Light and Power

Condition Assessment for J.B. Sims Generating Station
February 14, 2018

Condition Assessment of Sims Unit 3

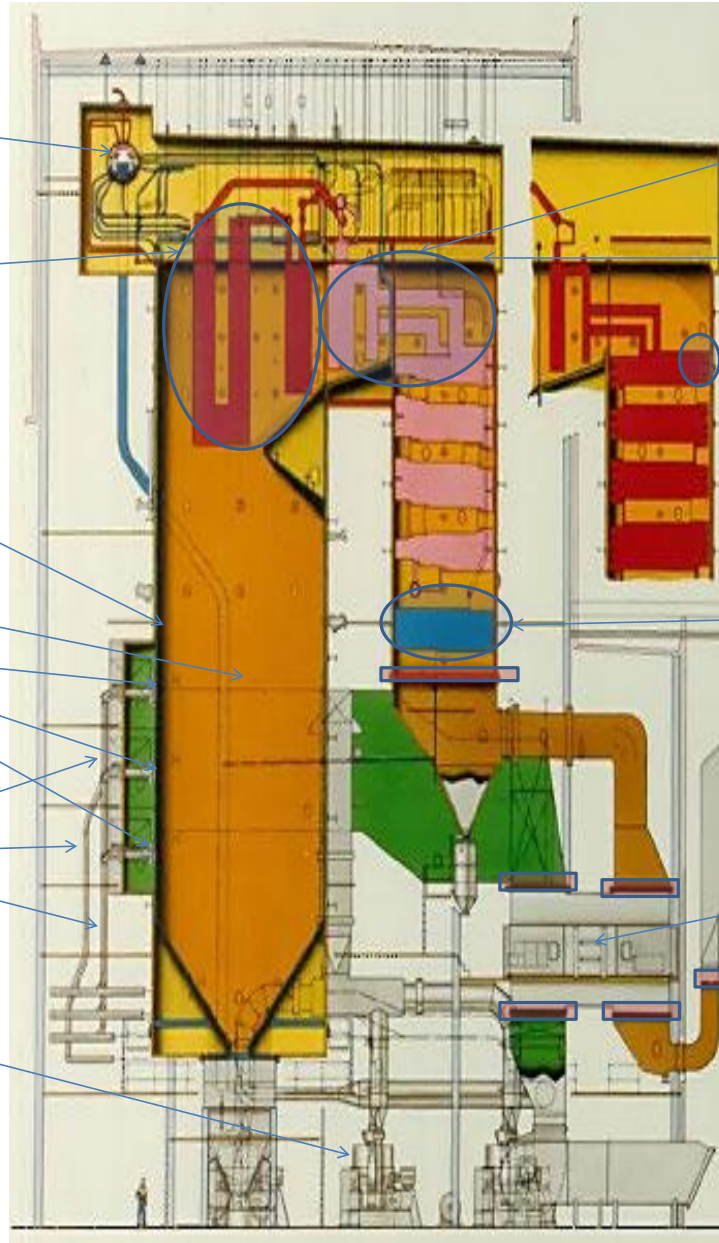
Note: **Safety Alert Warning** was issued by Babcock and Wilcox in October 2017 indicating graphitization of carbon-molybdenum steels for materials SA 209 and SA335 P1. These grade steels are contained in Sims Unit 3 superheater tubes, headers, and connections. Also contained in reheat tubes. Consulting with Babcock and Wilcox (OEM) on actions that should be taken.
